NUMBER: 08-001-19

Flash Over The Air (FOTA) Software Update UAQ Radio

2018 (JL) Jeep Wrangler

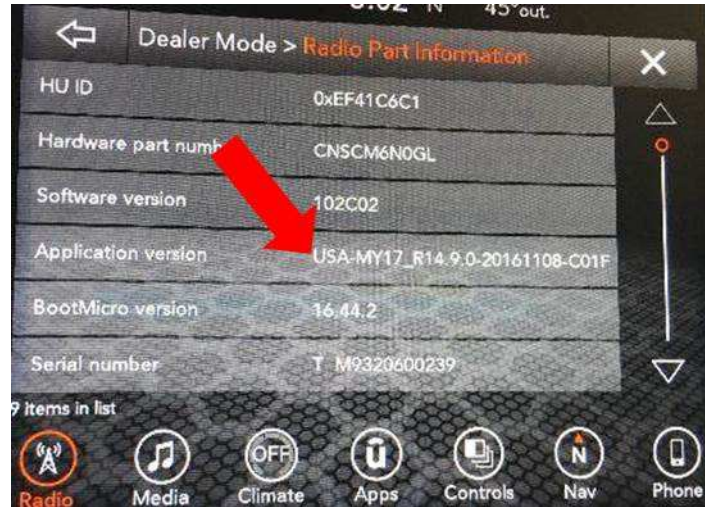
**Fig. 1****Radio Software Level Screen**

1. Verify the radio software version. Radio must be in Dealer Mode to verify by following these steps:
 - a. Push and hold the front defrost, driver temperature up and temperature down buttons simultaneously until the 'Dealer Mode' screen appears (approximately seven seconds). Release buttons.
 - b. Select "Radio Part Information". The software version will be listed next to "Application Version" [Step 1](#).

2. Is the radio software level (Application Version) at or higher than 21.10?
 - YES>>> The radio software is already up to date. Normal diagnostic should be performed.
 - NO>>> Proceed to [Step 1](#) of the Repair Procedure.

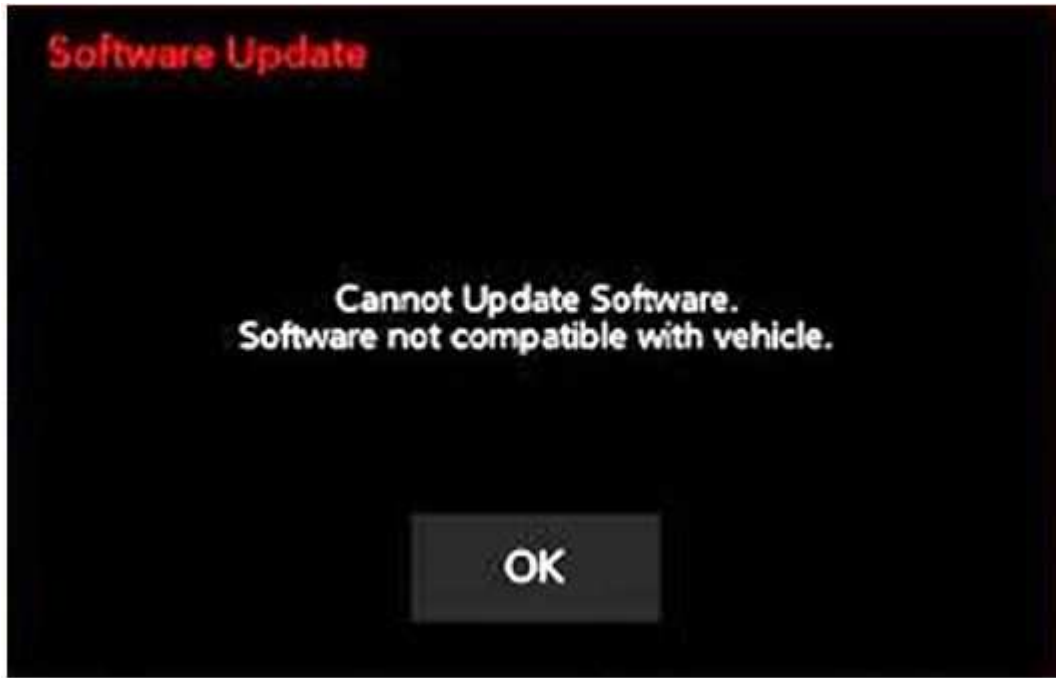
Fig. 5
Software Not Compatible

10. If the screen in (Fig. 5) is displayed, the USB flash drive was not set up correctly. Use a top name brand USB flash drive and create a new USB flash drive. Start the update again.

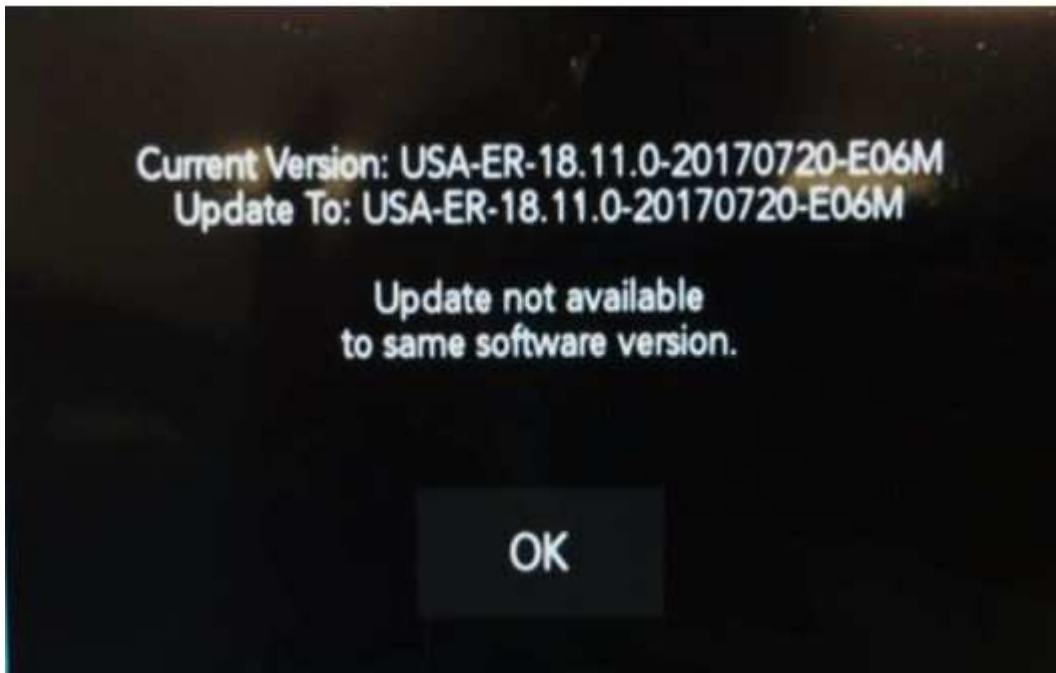
Fig. 6
Screen Displayed When Radio Software Level Is Up To Date

11. If the radio software is up to date, the screen in (Fig. 6) will be displayed. Press "OK" and remove the USB flash drive.

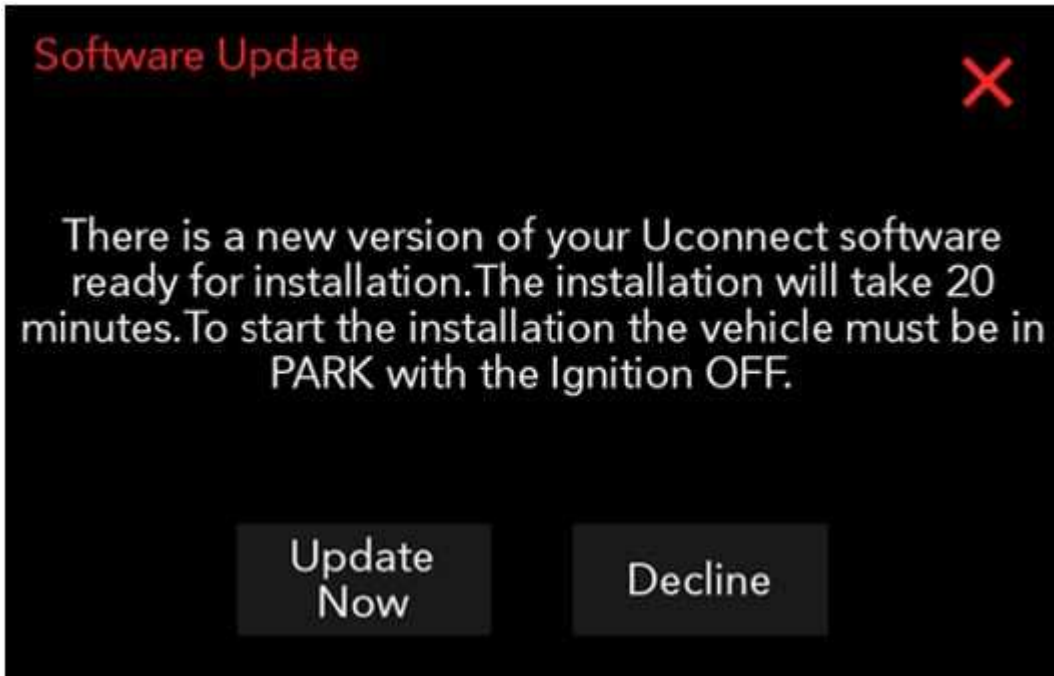
Fig. 7
Software Update Is Available

12. Once the system has verified there is an available update, press the “Update Now” button. Make sure the vehicle is in park. **Turn off the ignition, (Fig. 7) .**

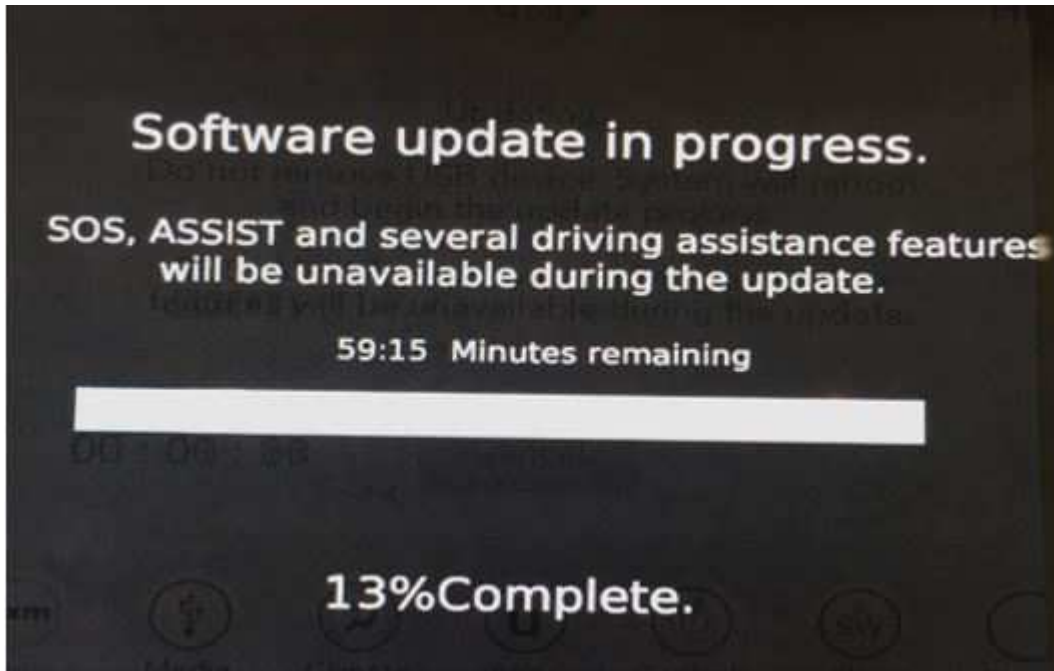
Fig. 9
Software Update In Progress

14. The radio will reboot and the update will begin. The update should only take 25 minutes, the timer on the screen may display the incorrect time remaining, (Fig. 9) .

NOTE: The completion indicator may not reach 100%, even though the software update has been completed. Once the software update has finished, the radio and display screen will turn off.

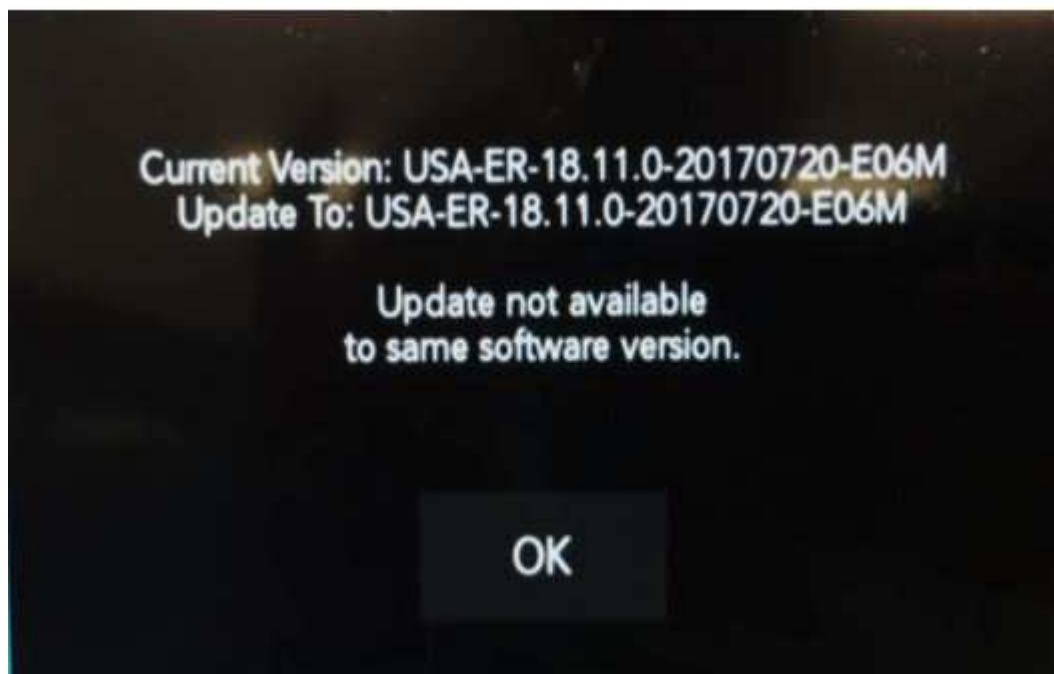
Fig. 10
Radio Software Has Been Updated.

15. After the update has completed, the radio will shut down. With the USB flash drive still inserted in the USB port, turn the ignition back to the run position. If the radio has been updated correctly, the screen in (Fig. 10) will be displayed. Press "OK" and remove the USB flash drive.
