STAR ONLINE PUBLICATION

Case Number: S1408000384 Rev. H

Symptom/Vehicle Issue: Start Stop Charging Warning Lamp Illuminated On, Intelligent Battery Sensor (IBS) State of Charge (SOC) Inaccurate, Battery Charging Message, Presence of IBS Related Diagnostic Trouble Codes (DTCs), or Battery Warning Lamp On

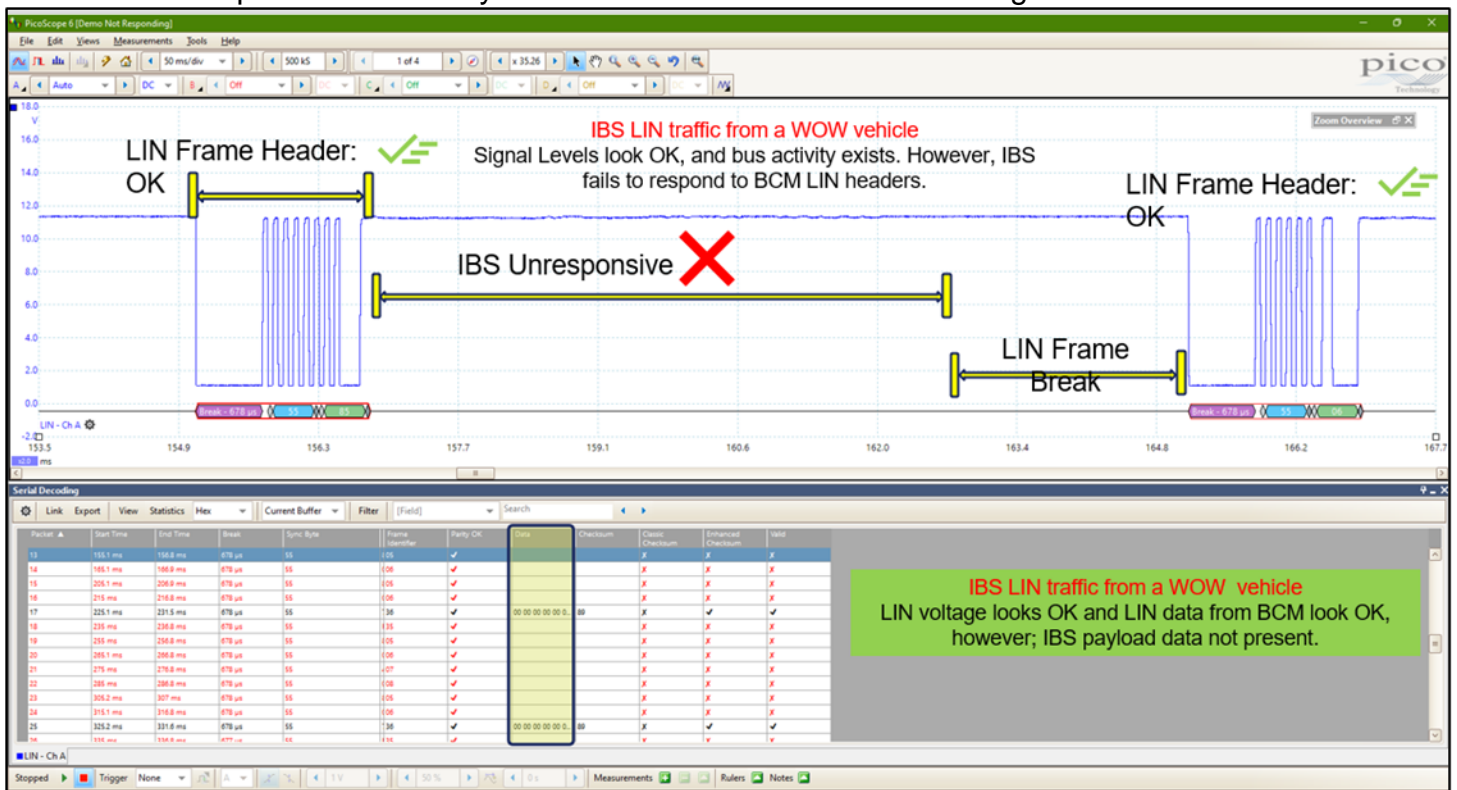
3. Verify power to IBS by back probing the IBS 2-way connector (pin 2, "RD" wire).
 - o If voltage is lower than 11.8V, follow normal procedures for low batteries.
4. Verify IBS feed fuse state. Replace the fuse if needed.
5. Verify LIN bus activity with Mopar scope.
 - o Config scope to LIN monitor if feasible.
 - o Replace the IBS only based confirmation from the LIN diagnostic.

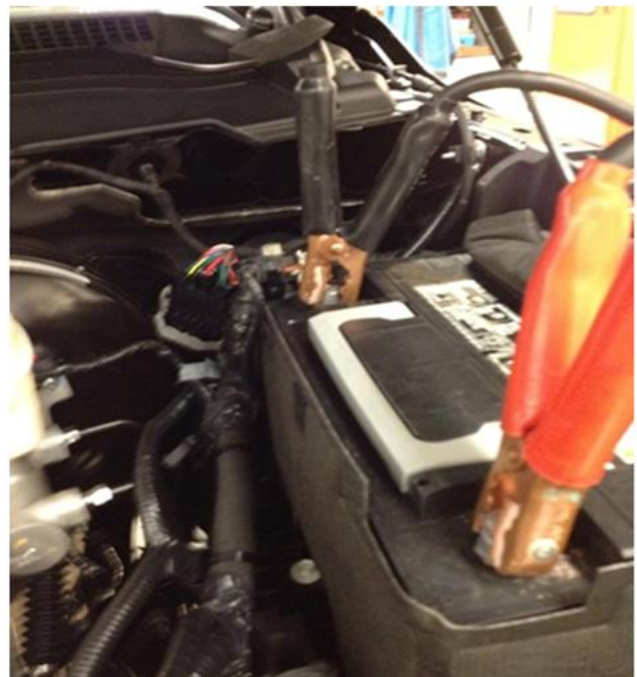
Improper IBS Charging

In-Vehicle systems is not an issue. Please note to charge through the IBS or tie negative clamp to Body/engine ground. Customers, Dealers, Mechanics, and Engineers usually want to place the negative clamp on the pole of the battery. This creates Blind charging. **“DO NOT BLIND CHARGE”** See below proper connections for charging.

Do not put Negative clamp on IBS Pole clamp

Do not remove IBS for charging

- IBS SOC adaptation is needed after charging the batteries.
- Note IBS will self-adapt in the next available quiescent state.
- A common misdiagnosis is Battery light illuminated. The IBS has NOTHING to do with this light. The battery Light is indicative of a “CHARGING SYSTEM and condition of the battery”
