## STAR ONLINE PUBLICATION

**Case Number:** S1824000004

**Symptom/Vehicle Issue:** HVAC Has Unequal Heat Or Cooling

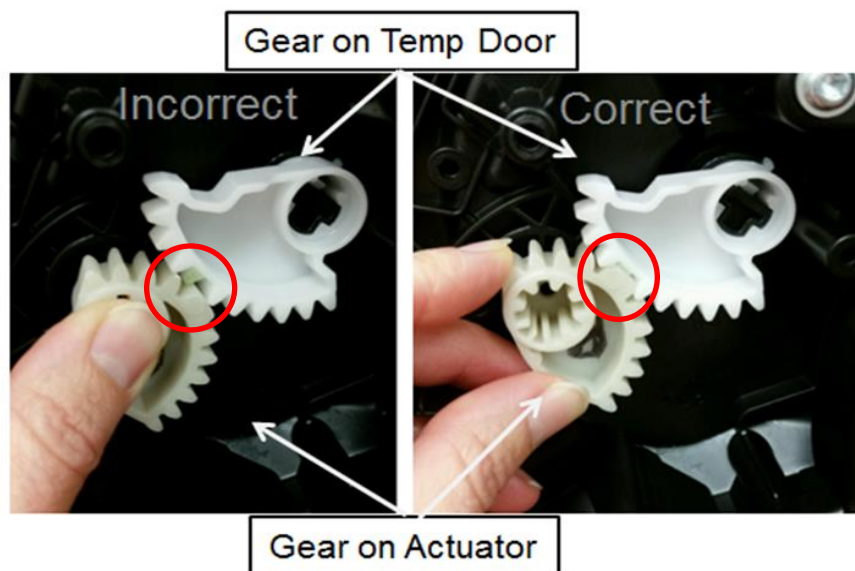
**Discussion:** If a customer has a concern of one side of vehicle being warmer or colder than the other, the gear set between the actuator and temperature door could be misaligned and have come apart from each other. If the gear set is out of “timing”, the actuator does not need to be replaced. Correcting the gear tooth alignment will repair the condition.
