**NUMBER:** 08-003-21

Improved Steering Feel

2018 - 2020	(JL)	Jeep Wrangler
2020	(JT)	Jeep Gladiator

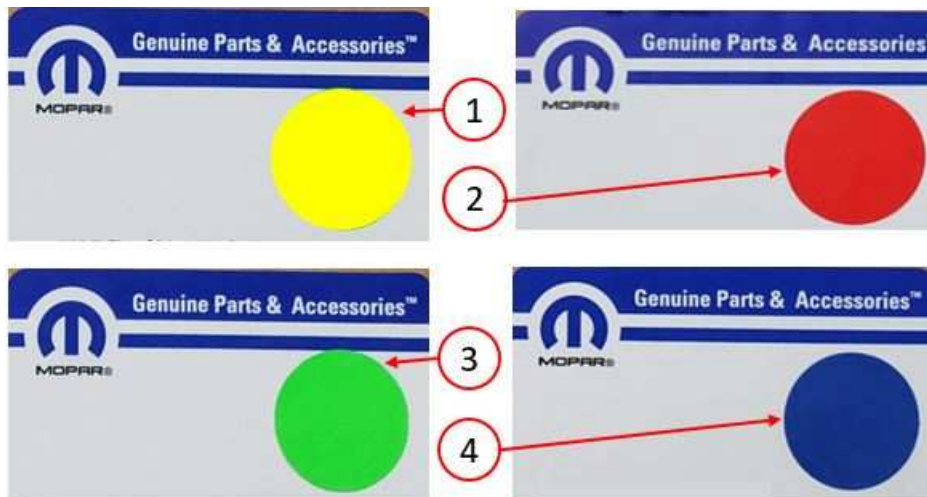
Fig. 1

The Steering Gear Parts Label Has A Color Dot On It To Help Confirm The Correct Steering Gear Was Ordered

- 1 - Yellow Dot, 68507576AA (JT Left Hand Drive (LHD))
- 2 - Red Dot, 68507569AA (JL 4 Door LHD, **W/O EXJ 3.0 Diesel**)
- 3 - Green Dot, 68507574AA (JL 4 Door LHD, **With EXJ 3.0 Diesel**)
- 4 - Blue Dot, 68507571AA (JL 2 Door LHD)
