WARRANTY BULLETIN

NO: D-23-04

SUBJECT: 2018 - 2023 (Current) Jeep
Wrangler (JL) and 2020 - 2023 (Current)
Jeep Gladiator (JT) - Corrosion Warranty
Claim Simplification (Rev. A)

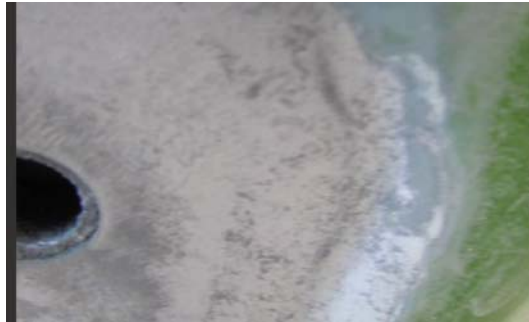
1. Pitting found after sanding the affected area (Fig. 1)

Pitting Found After Sanding Example (Fig. 1)

Note: If pitting is found during the sanding process, please use LOP 23-75-XX-XX for up to 0.5 hours in conjunction with the 23-85 replacement LOP.

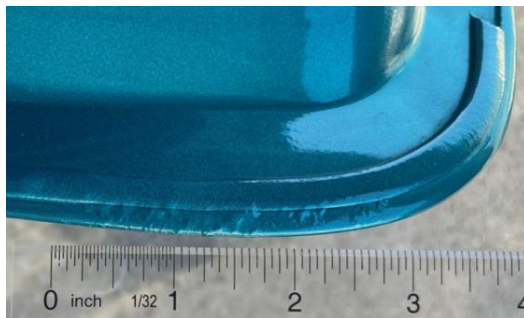
2. Corrosion found on the seam of the panel (Fig. 2)

Seam Panel Area Examples (Fig. 2)

Note: If corrosion is found on the seam of the panel, the door shell will be replaced. No additional sanding in the hinge or seam area is supported.
