REFERENCE:	TSB: 08-003-22 REV. A GROUP 08 - Electrical	Date:	December 16, 2022	REVISION:	08-003-22 and 08-133-21
VEHICLES AFFECTED:	<p> 2019 - 2023 (KL) Jeep Cherokee 2018 - 2020 (WD) Dodge Durango 2018 - 2021 (MP) Jeep Compass 2019 - 2021 (BV) Jeep Renegade 2018 - 2022 (LA) Dodge Challenger 2018 - 2022 (LD) Dodge Charger 2018 - 2022 (LX) Chrysler 300 2018 - 2023 (JL) Jeep Wrangler 2020 - 2023 (JT) Jeep Gladiator 2018 - 2021 (DS) RAM 1500 Pickup 2018 (WK) Jeep Grand Cherokee 2018 (BU) Jeep Renegade 2018 (DJ) RAM 2500 Pickup 2018 (D2) RAM 3500 Pickup 2018 (DD) RAM 3500 Cab Chassis 2018 (DF) RAM 3500 <10K Cab Chassis 2018 (DP) RAM 4500/5500 Cab Chassis </p> <p> NOTE:This bulletin applies to vehicles equipped with a Uconnect 4C Nav With 8.4” Display radio (Sales Codes UAQ or UCQ). </p> <ul style="list-style-type: none"> • This bulletin applies to JL and JT vehicles built on or before November 23, 2022 (MDH 1123XX). • This bulletin applies to KL vehicles built on or before November 21, 2022 (MDH 1121XX). 			MARKET APPLICABILITY: <input checked="" type="checkbox"/> NA <input type="checkbox"/> IAP <input type="checkbox"/> EE <input type="checkbox"/> MEA <input type="checkbox"/> SA <input

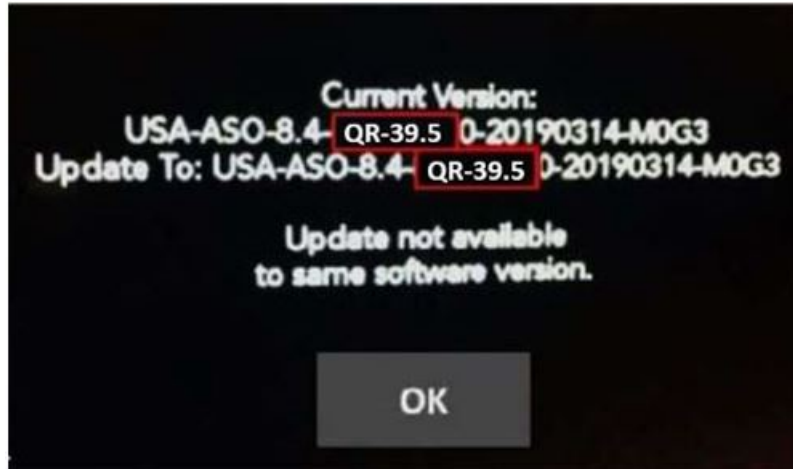
Fig. 5

Screen Displayed When Radio Software Level Is Up To Date

11. If the radio software is already up to date, the screen in (Fig. 5) will be displayed. Press “OK” and remove the USB flash drive.

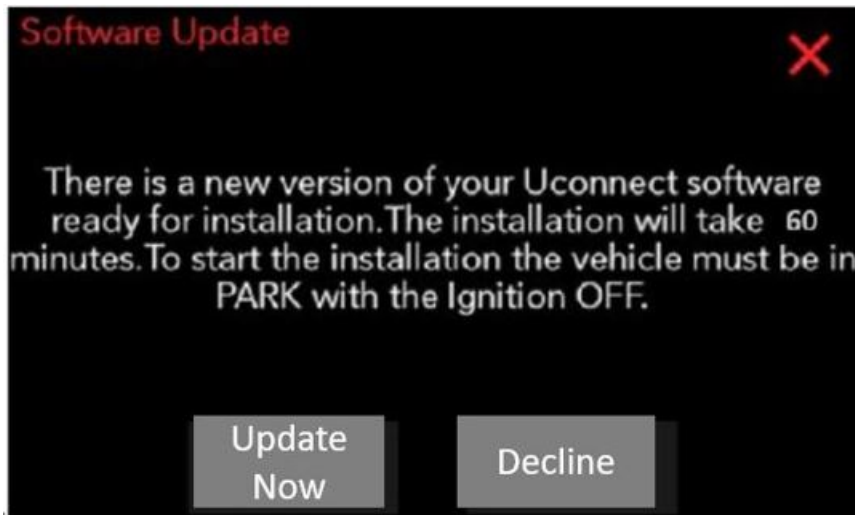
Fig. 6

Software Update Is Available

12. Once the system has verified there is an available update, press the “Update Now” button. Make sure the vehicle is in park, **DO NOT turn off the ignition** (Fig. 6) .

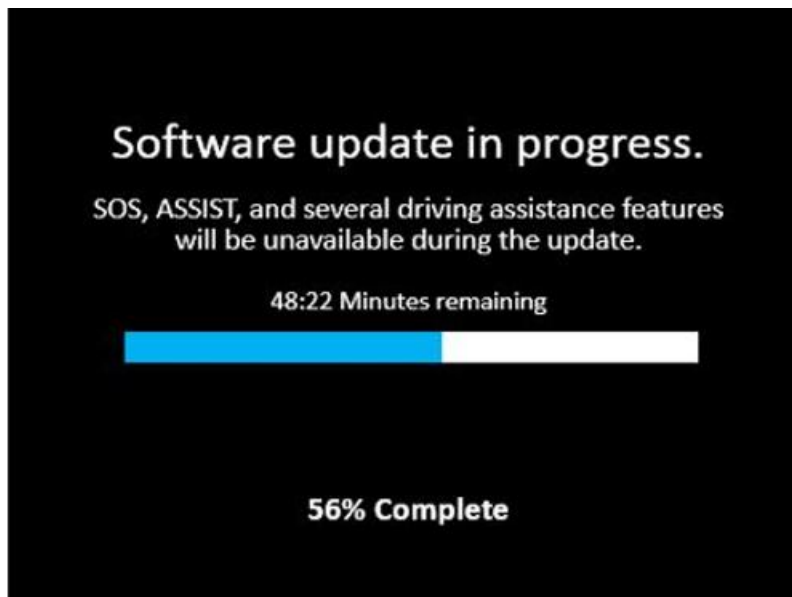
Fig. 8
Software Update In Progress

14. The radio will reboot and the update will begin. The update should only take 25 minutes, the timer on the screen may display the incorrect time remaining, (Fig. 8) .

NOTE: The completion indicator may not reach 100%, even though the software update has been completed. Once the software update has finished, the radio and display screen will turn off.
