# Equipment Campaign 29A

## Frame Stud

*This recall applies only to the above short wheelbase frames (Body Style: JL72) intended for use on 2018-2023 (JL) Jeep Wrangler vehicles.*

Some of the above frames may have been built with an unnecessary and unused frame stud. When installed in a vehicle, the frame stud may contact the fuel tank in a crash, which, in certain circumstances, can cause a fuel leak. A fuel leak in the presence of a competent ignition source may result in a fire, increasing the risk of occupant injury and/or injury to persons outside the vehicle.

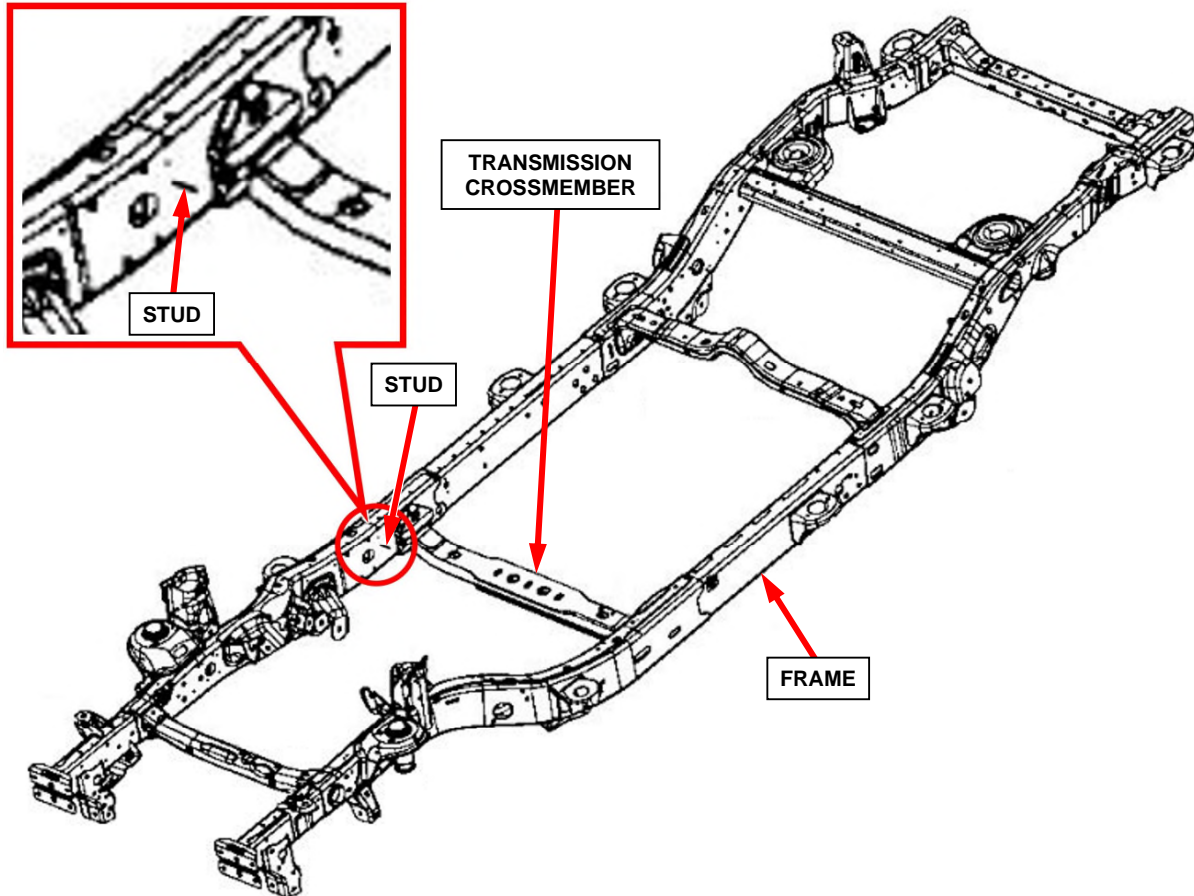
Visually look for a stud on the frame in the location shown in (Figure 1).

Figure 1 – Frame Stud Location – Inspect for Frame Stud

- **Frame Stud Located:** Proceed to **Section D. Frame Stud Removal** for stud removal procedure and perform only **Steps 1 - 3** then claim the “Off Vehicle” stud removal LOP.
- **Frame Stud Does NOT Exist:** No further action required. Claim the “Off Vehicle” stud inspection LOP.

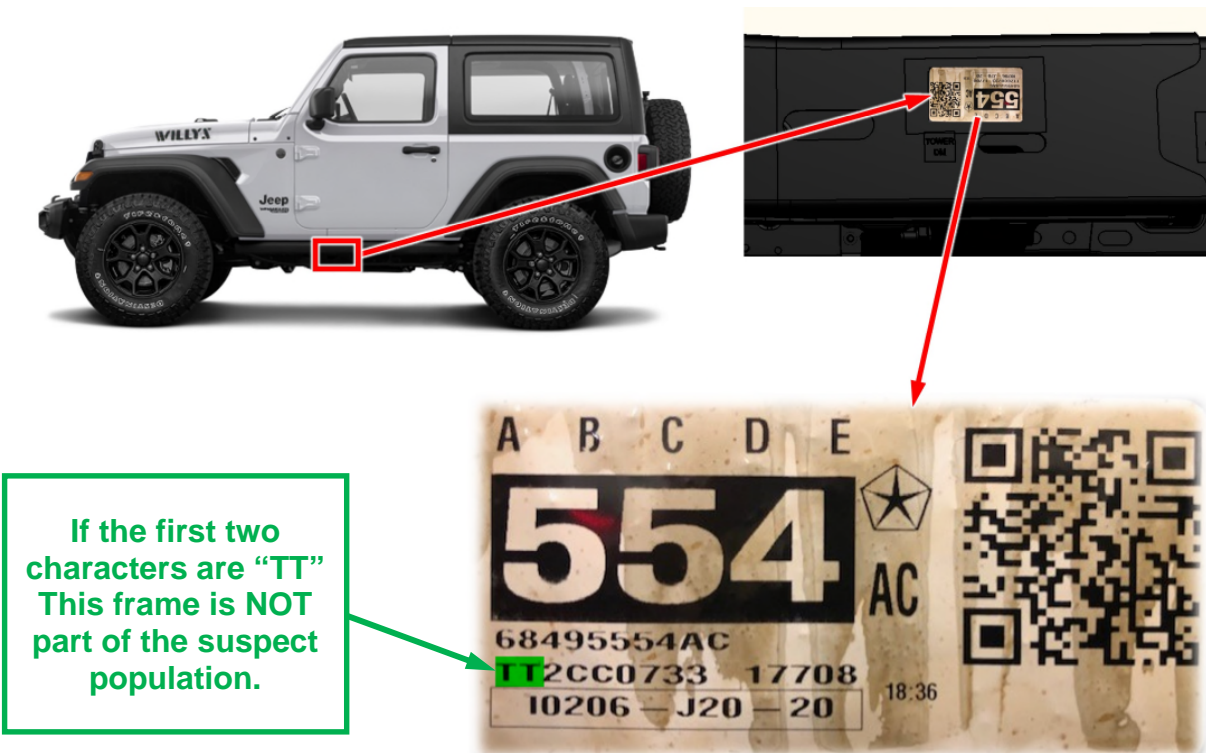
1. Look for a label on the driver side frame rail just rearward of the door hinges.
2. If the label looks like (Figure 2) and is readable not missing or covered over by an aftermarket coating material, then read the label as instructed in (Figure 2).
3. If the label does NOT look like (Figure 2) or is unreadable, missing, or covered over by an aftermarket coating material, then proceed to **Section C. Frame Stud Inspection.**

Figure 2 – Front Reinforcement Crossmember

4. What were the first two characters on the label as instructed in (Figure 2).
  - First two characters were “TT” – No further action required. Claim the appropriate inspection LOP and return vehicle to customer.
  - First two characters were some other combination of characters - Proceed to **Section C. Frame Stud Inspection.**

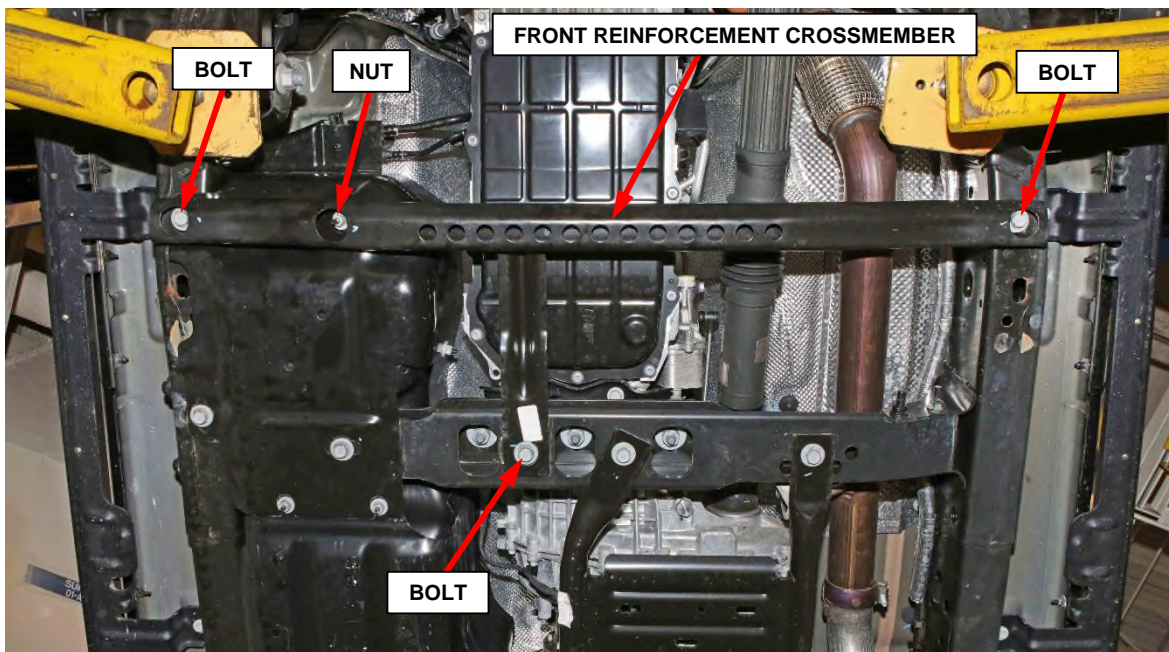
1. Raise and support the vehicle.
2. Remove the fasteners, three bolts and one nut securing the front reinforcement crossmember then remove the crossmember from the vehicle (Figure 3).

**Figure 3 – Front Reinforcement Crossmember**

8. Position the front reinforcement crossmember to the vehicle then install and tighten the three bolts and one nut (Figure 3).
  - Bolts crossmember to outer frame rails: 95 N·m (70 ft. lbs.)
  - Bolt crossmember center leg to crossmember: 75 N·m (55 ft. lbs.)
  - Nut: 20 N·m (15 ft. lbs.)

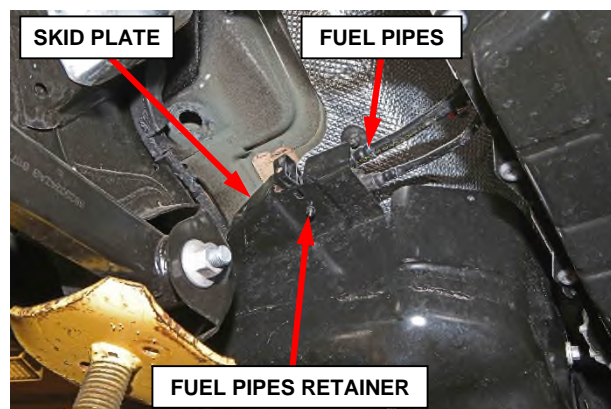
3. Release the fuel pipe retainer from the fuel tank front skid plate (Figure 4).

**Figure 4 – Fuel Pipes Retainer**

7. Install the fuel pipe retainer to the fuel tank front skid plate (Figure 4).

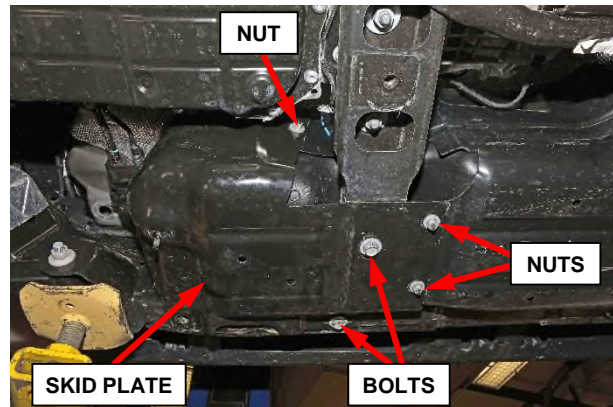
4. Remove the fasteners, two bolts and three nuts securing the fuel tank front skid plate then remove the skid plate from the vehicle (Figure 5).

**NOTE:** Nut locations on skid plate are slotted so nuts do not need to be fully removed.

Figure 5 – Fuel Tank Front Skid Plate

6. Position the fuel tank front skid plate to the vehicle then install and tighten the fasteners, two bolts and three nuts (Figure 5).
  - Bolts: 75 N·m (55 ft. lbs.)
  - Nuts: 20 N·m (15 ft. lbs.)

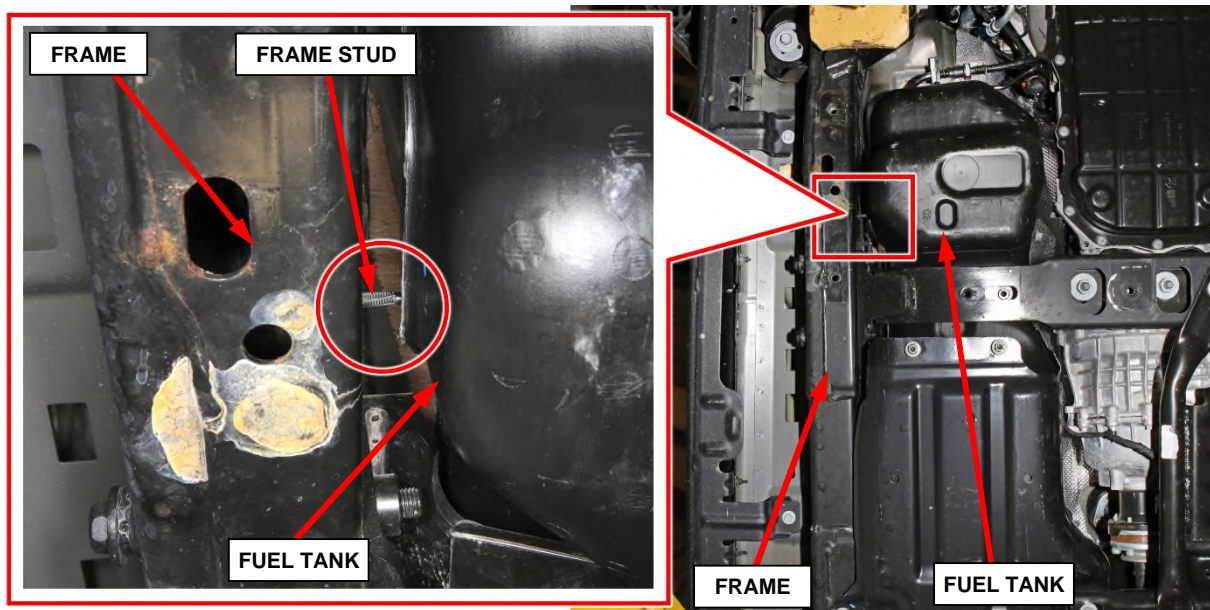
5. Visually look for a stud on the frame in the location shown in (Figure 6).
- **Frame Stud Located:** Proceed to **Section D Frame Stud Removal** for stud removal procedure. Do NOT continue with Inspection Procedure.
  - **Frame Stud Does NOT Exist:** Continue with **Inspection Procedure** to reassemble the vehicle. Section D is not required if no stud exists.

Figure 6 – Frame Stud Location – Inspect for Frame Stud

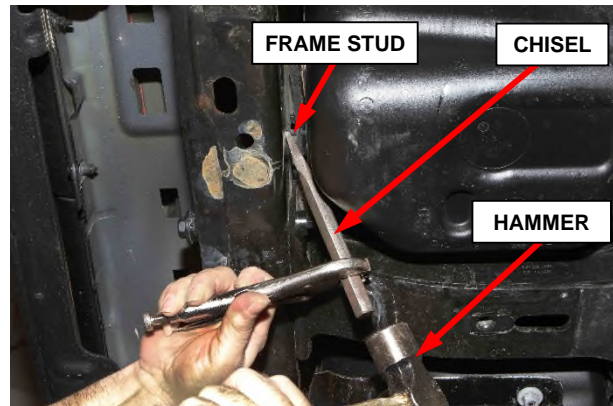
**Figure 7 – Remove Frame Stud**

1. Using a suitable chisel and hammer, cut the stud off as close to the frame as possible (Figure 7).

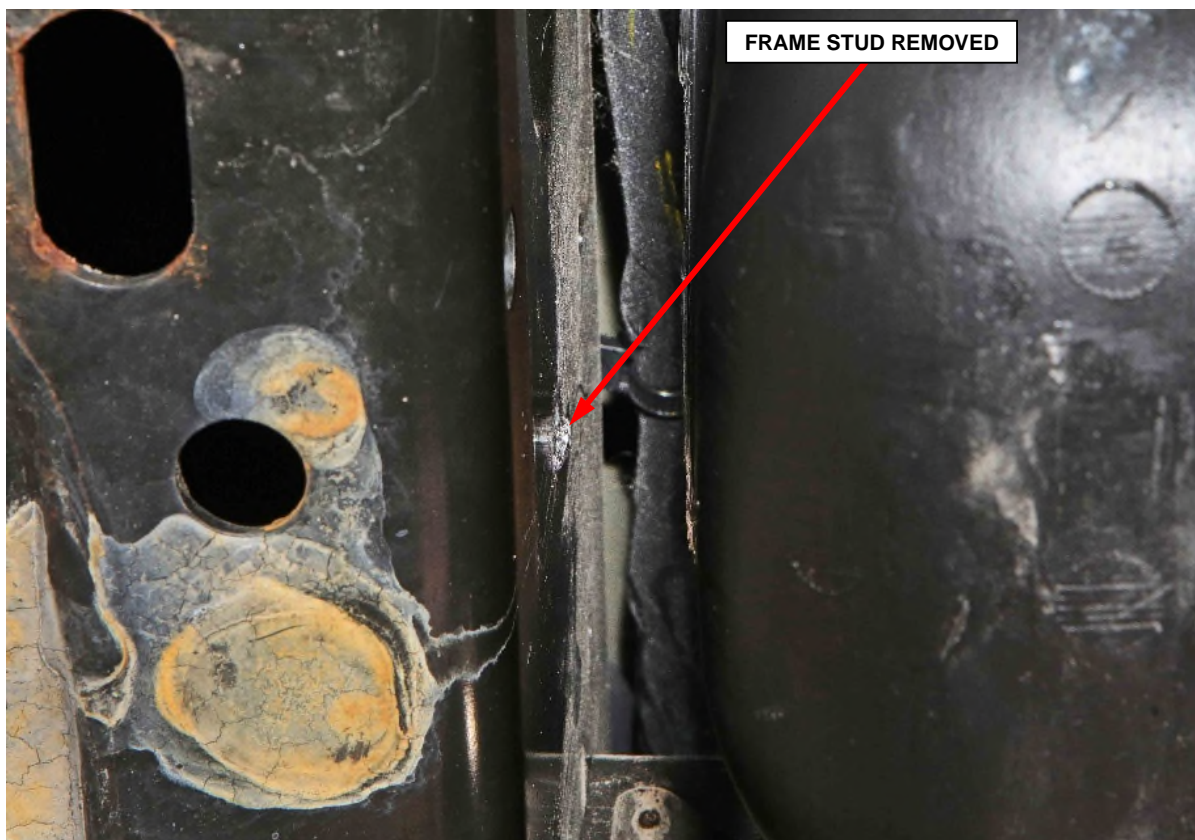
2. After removing the frame stud (Figure 8).

**Figure 8 – Frame Stud Removed**

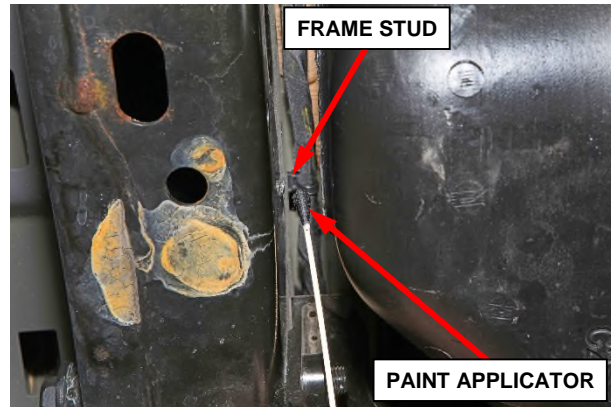
**Figure 9 – Apply Paint to Frame Stud**

3. Obtain black spray paint specified in the Parts Section and a brush or cotton swab or suitable applicator. Spray a small amount of paint into a cup to dip the applicator or directly onto the applicator then apply the paint to the vehicle frame covering any bare exposed metal in the location of the removed frame stud (Figure 9).
