2018 Wrangler Accessories and General Park Assist Sensor Tips

REFERENCE BOOK AND TECH NEWS
June 2018

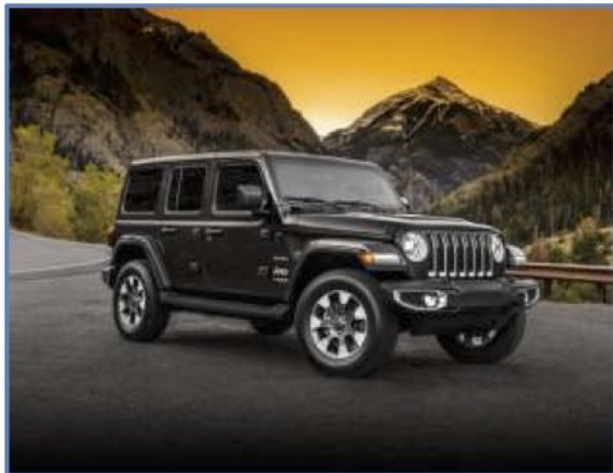
Figure 1: 2018 New Model Jeep Wrangler

This month's Master Tech covers the installation of a remote start and trailer harness kit for the 2018 new model Jeep Wrangler (Figure 1).

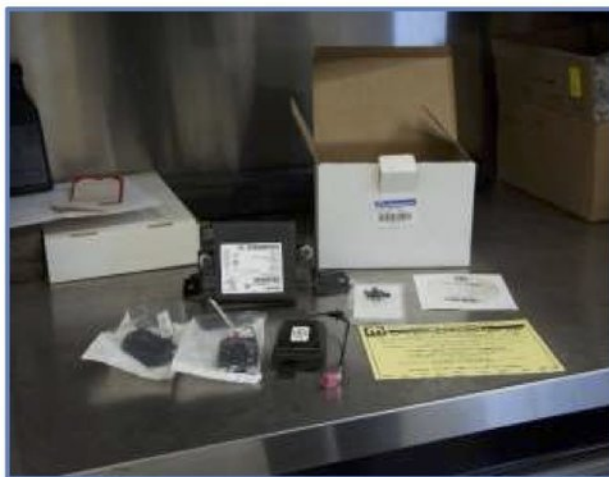
Figure 2: Remote Start Kit

Installation of Mopar's remote start kit (Figure 2) for the new model 2018 Jeep Wrangler is straightforward.

Each kit is VIN specific and comes with everything needed to perform the installation, including:

- A new RF Hub
- A remote start antenna
- Two new FOBs with pre-cut keys
- Two push-pin retainers
- A customer information card

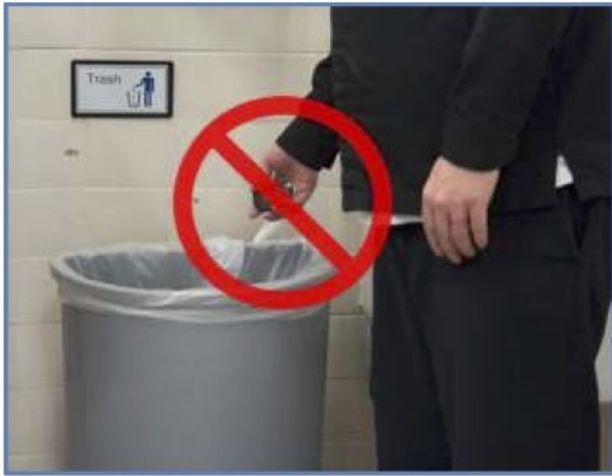
Figure 3: Old FOBs

Do not throw away the old FOBs (Figure 3). The old FOBs will still work but will not be able to perform the remote start function.

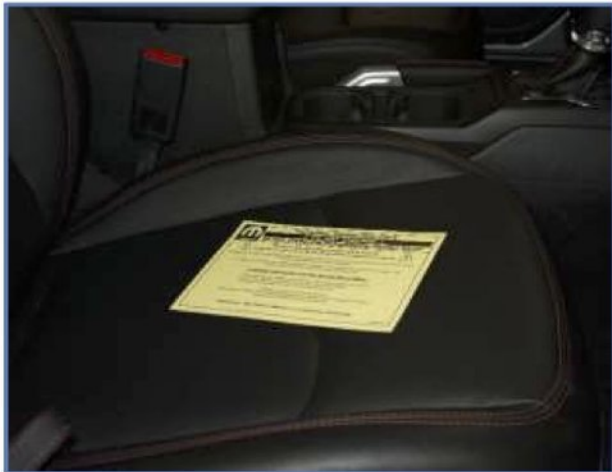
Figure 4: Information Card

Do not throw away the information card (Figure 4) either. Instead, leave it in the vehicle for the customer.

The customer information card explains how to synchronize original FOBs that were not present at the time of installation.

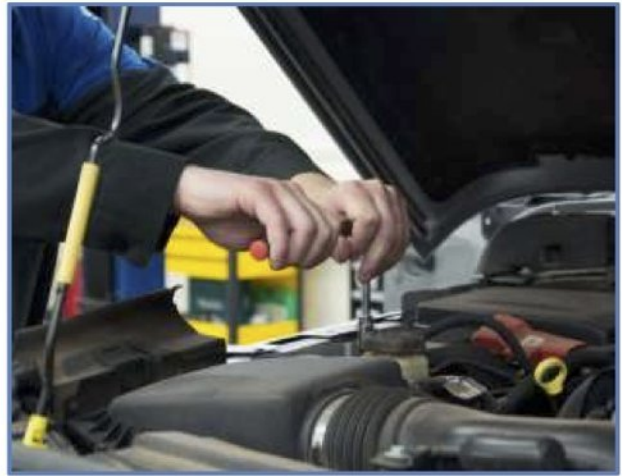
Figure 5: Disconnecting the Battery

Installation of the remote start kit begins by disconnecting the battery (Figure 5).

Some Wranglers are equipped with an auxiliary battery for engine stop start (ESS) and require a unique power-down procedure.

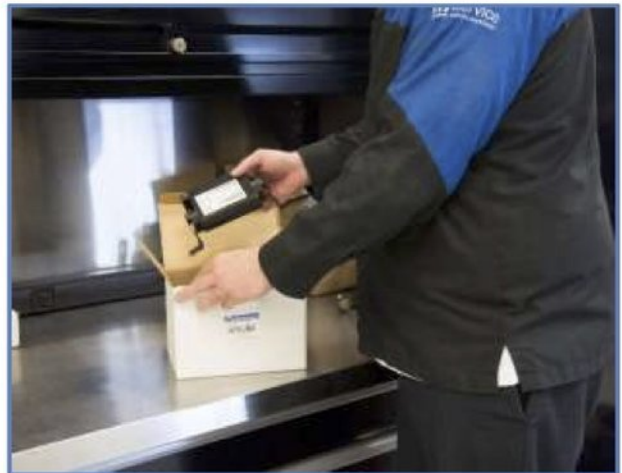
Figure 6: New RF Hub

The new RF Hub (Figure 6) replaces the original RF Hub located behind the left quarter trim panel.

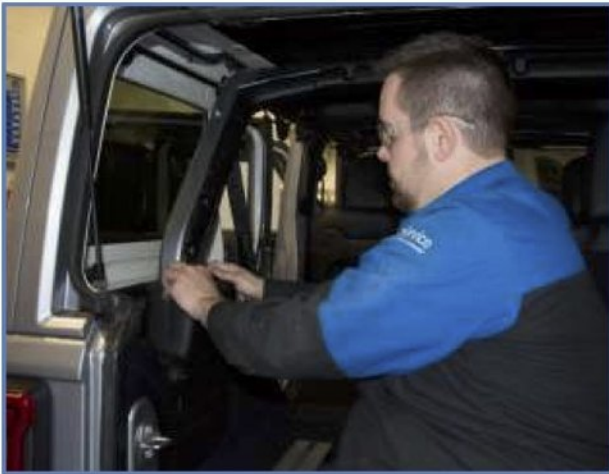
Figure 7: Left Rear-Quarter Trim Panel

Pulling back on the top of the quarter trim panel (Figure 7), instead of completely removing it, can save some time.

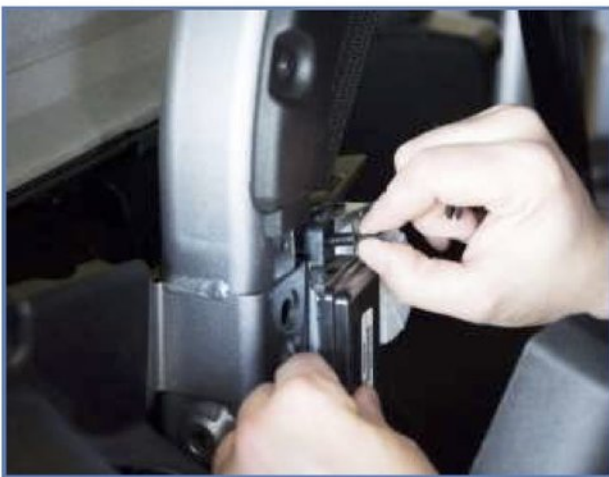
Figure 8: Remote Start Antenna

The remote start antenna (Figure 8) is secured just behind the left rear seat-belt retractor using the push-pin retainers from the kit.

Follow the instruction sheet when routing and connecting the antenna cable.

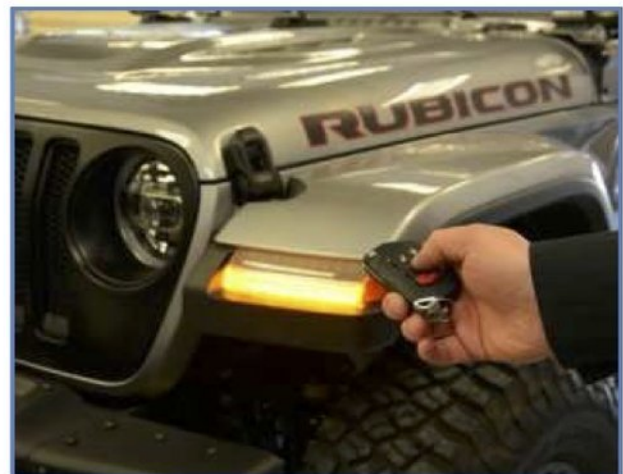
Figure 9: Confirming the Remote Start Function

Confirm that the remote start functions (Figure 9) using each of the new FOBs.

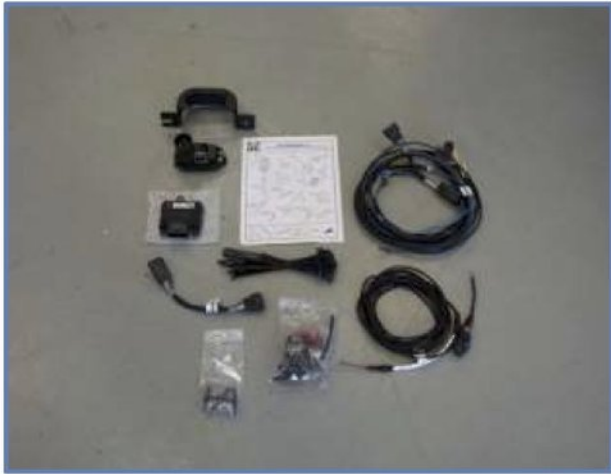
Figure 10: Trailer Hitch Wiring Kit

Mopar designed a trailer hitch wiring kit (Figure 10) specifically for the new model 2018 Jeep Wrangler.

- A module
- Several harnesses
- Tie-straps
- Trailer connector

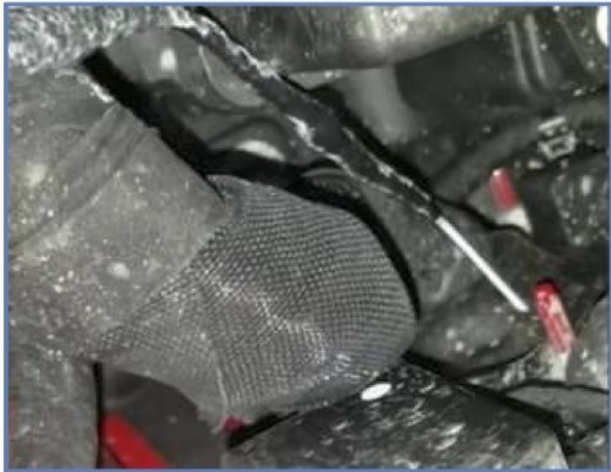
Figure 11: Routing Harness Through Bulkhead

Installation requires routing the harness through the bulkhead (Figure 11) and body to reach the rear bumper.

Removing some interior trim is required. Be careful when removing the kick-panel because there are two different kick-panel designs. Refer to Service Information for more details.

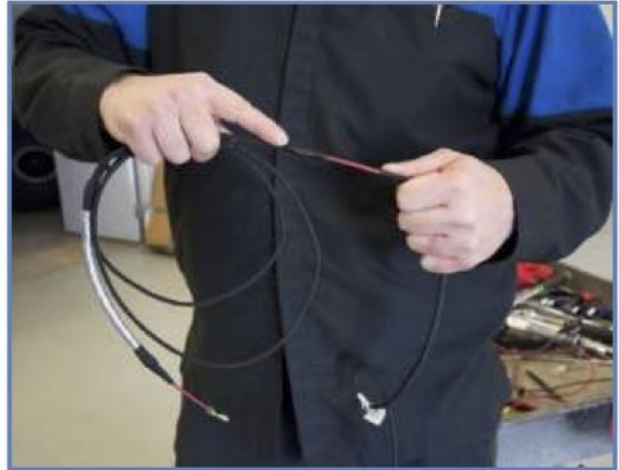
Figure 12: Red Wire Taped to Harness

Before routing the harness, take a moment to find the red wire taped to the harness (Figure 12).

The red wire is purposely taped to the harness to make passing the harness through the bulkhead grommet easier.

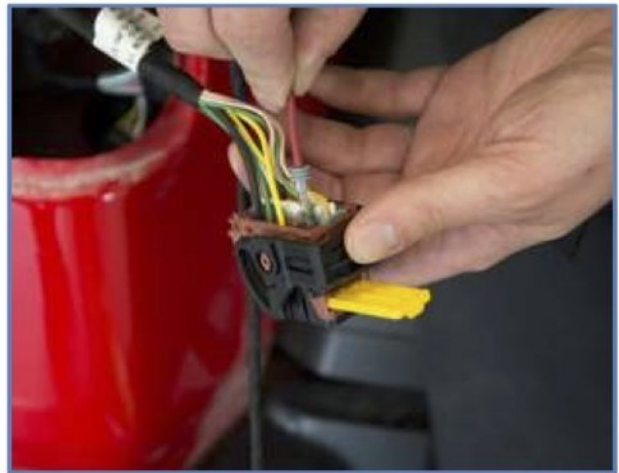
Figure 13: Main Harness Module Connector

After routing the harness, the red wire is un-taped and the attached terminal is installed into the main harness module connector (Figure 13).

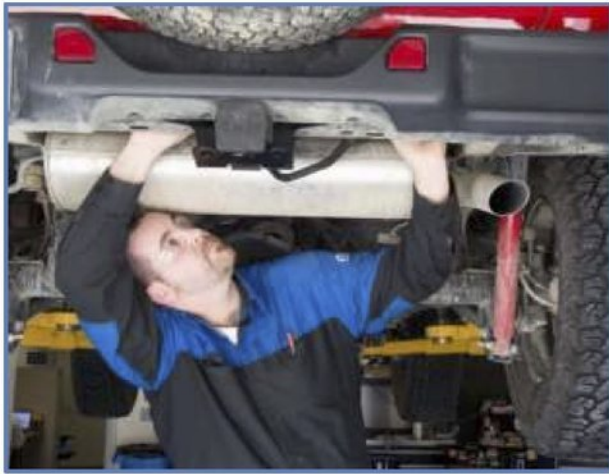
Figure 14: Rear Frame Cross-member

A section of the trailer hitch harness is installed on the top of the rear frame cross-member (Figure 14).

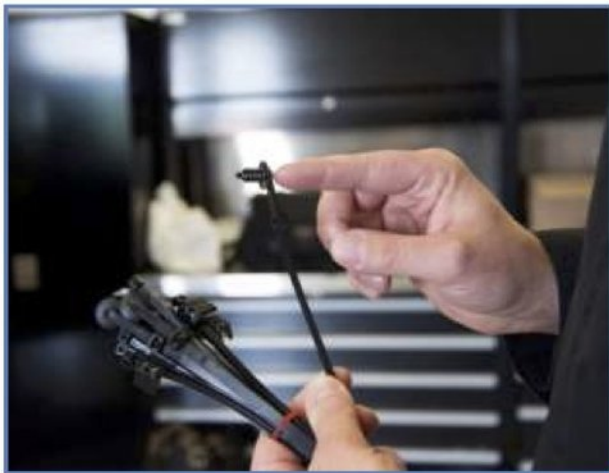
Figure 15: Tie-strap Fasteners

Tie-straps (Figure 15) with integrated "Christmas tree" style fasteners are provided to secure the harness into the pre-drilled holes in the rear-frame cross-member.

The holes in the cross-member can be difficult to access, and hard to see.

Feeling for the holes is the easiest way to complete this step.

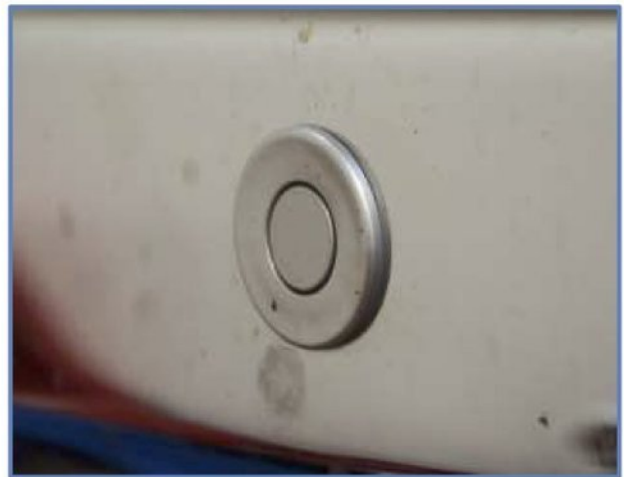
Figure 16: Park Assist Sensors

Park assist sensors (Figure 16) are used on many FCA vehicles and, from time to time, they may need to be serviced or replaced.

Park assist sensors are fragile by design and can be damaged if not handled with care. If a park assist sensor is dropped, it must be replaced. Never reused.

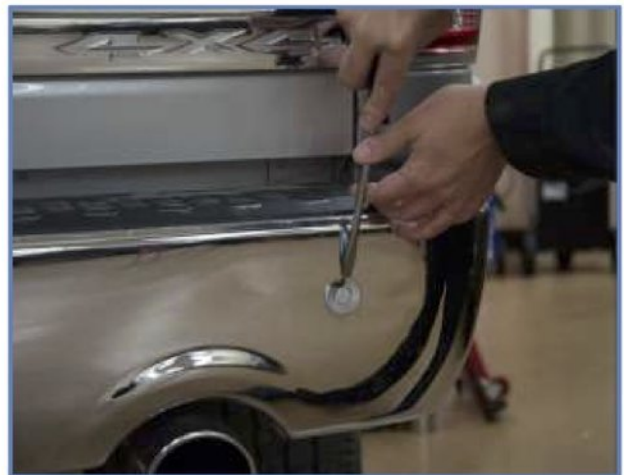
Figure 17: Needless Sensor Damage

Many sensors have been needlessly damaged (Figure 17) resulting in warranty chargebacks.

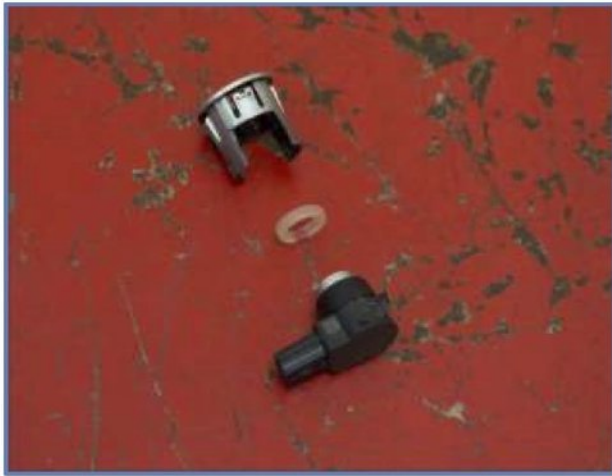
Figure 18: Sensor Components

Park assist sensors (Figure 18) consist of three main components:

- A sensor retainer
- A silicone ring
- A sensor assembly

Sensor retainers clip into holes in the bumpers. Two plastic tabs on each sensor secure the sensors into the retainers.

The silicone rings (sometimes called decoupling rings) act as isolators between the sensor membranes and retainers.

Sensor membranes must be isolated for the sensors to work correctly. Dirty park assist sensors can have a negative effect on system performance and, in some cases, cause DTCs to be set.

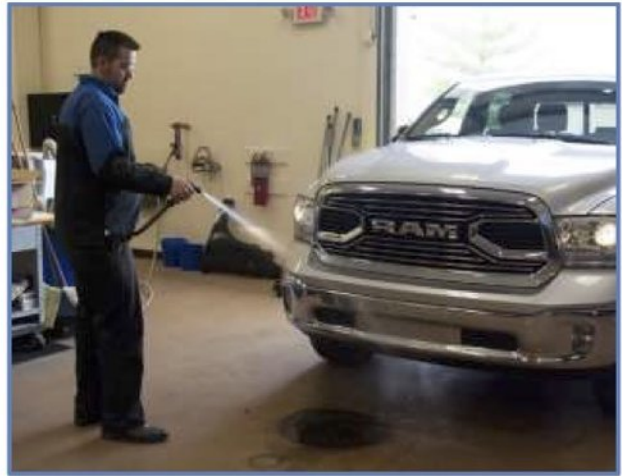
Figure 19: Rinsing Sensors From Outside

Before replacing a suspect sensor, a thorough cleaning is required first. A common misconception is that simply rinsing off the sensor from the outside (Figure 19) is good enough.

A three-step cleaning process is required to thoroughly clean the sensors.

1. Rinse off the outside of the bumper.
2. Rinse off the inside of the bumper.
3. Remove the sensor to clean between the sensor and retainer.

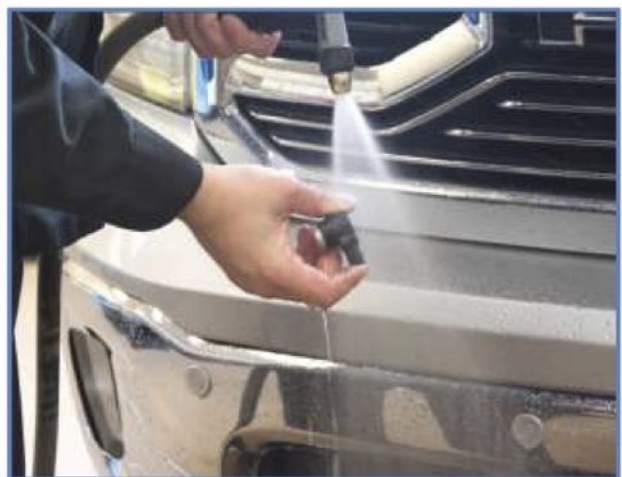
Figure 20: Cover Sensor Connector with Finger

When rinsing sensors, prevent water from entering the connector by covering it with your finger (Figure 20).

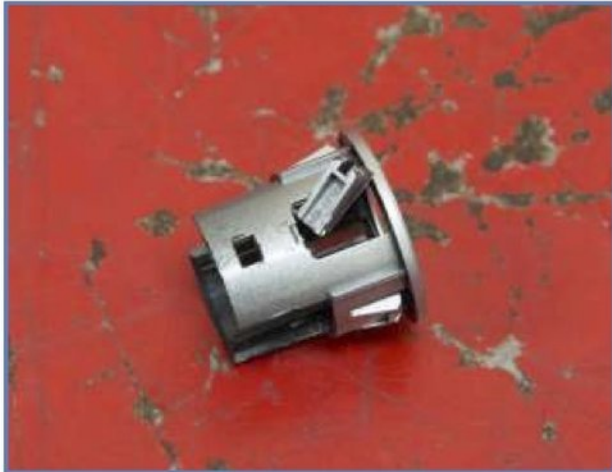
Figure 21: Broken Sensor Retainer

Retainers with broken tabs (Figure 21) will not allow the sensor to seat properly, and broken retainers are not covered under warranty.

To prevent breaking the retainer tabs, avoid using excessive pressure when removing the sensor. Do not release just one retainer tab and attempt to twist the sensor to remove it from its retainer. Doing so could result in a broken sensor, a broken retainer, or both.

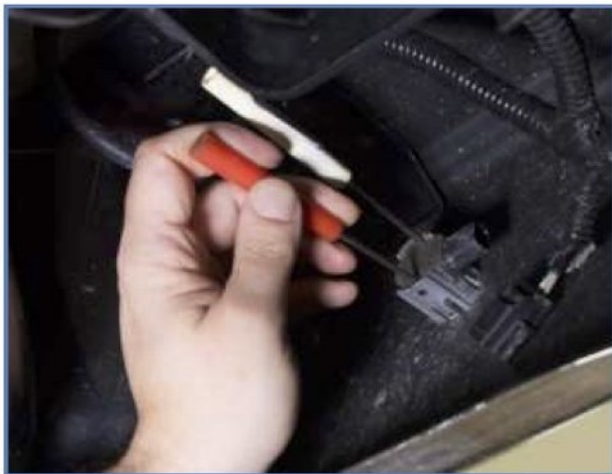
Figure 22: Preferred Sensor Removal

The preferred method for removing a park assist sensor (Figure 22) is inserting two pocket screwdrivers or similar flat-bladed tools between the sensor and the retainer.

There should never be a need to rotate the screwdrivers. With the tension released from the retainer tabs, pull the sensor straight out from the inside of the bumper.

Do not push from the membrane side. Pressing on the membrane will ruin the sensor.

With the sensor removed from the retainer, you can easily inspect for any dirt between the sensor and silicone ring. Do not forget to check for any dirt stuck on the inside of the retainer.

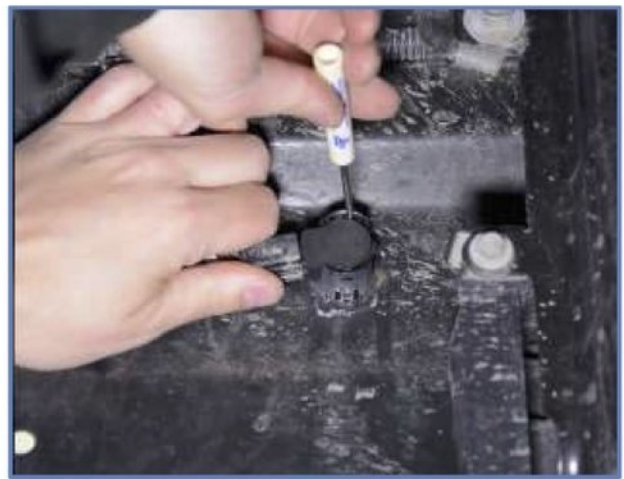
Figure 23: Twisting Sensors

Twisting a park assist sensor (Figure 23) during removal or installation can damage the delicate wiring inside the sensor.

Many sensors have lines printed on their sides. These lines should always line up. If they do not, that is an indication that the membrane may have been twisted in the past. Attempting to realign the sensor will not fix it.

The presence of certain codes like a "Short to Battery" DTC is another indication of a damaged sensor. Sensors damaged from twisting are not covered under warranty and will generate a chargeback.

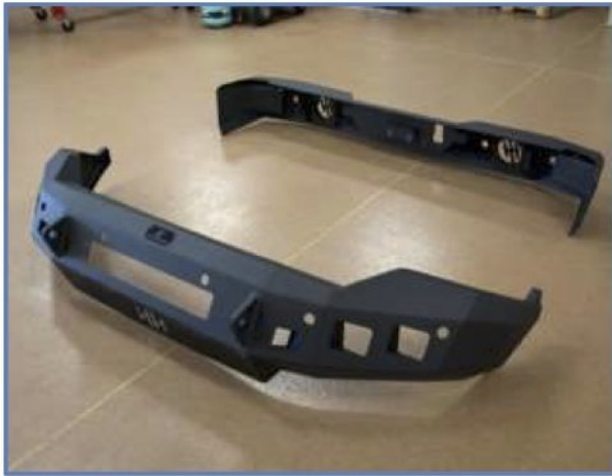
Figure 24: Aftermarket Bumpers

Twisted sensors are most commonly found when installed in aftermarket replacement bumpers (Figure 24). This is because aftermarket bumpers often skip the use of a retainer, relying on a “press fit” between the bumper and sensor body.

The smaller-sized holes make it difficult to insert the sensors into the bumpers without twisting them.

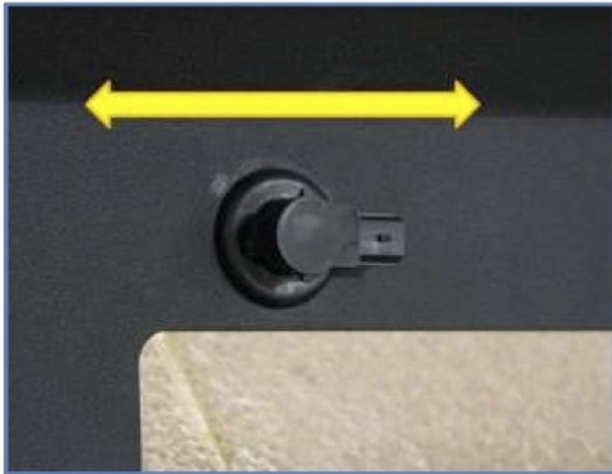
Figure 25: Horizontal Connectors

The connectors should always be horizontal (Figure 25). Twisting during installation can, and often does, result in a short or open circuit inside the sensor.

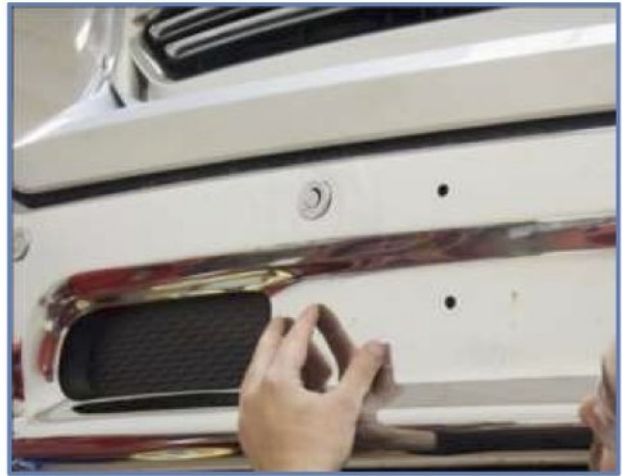
Figure 26: Incorrectly Installed Sensors

A sensor that is not fully seated and centered may indicate that a sensor has been installed incorrectly (Figure 26) in its retainer. Always make sure that the silicone ring is installed correctly and not rolled over. A “rolled over” silicone ring can cause incorrect sensor installation concerns and might even set a DTC.

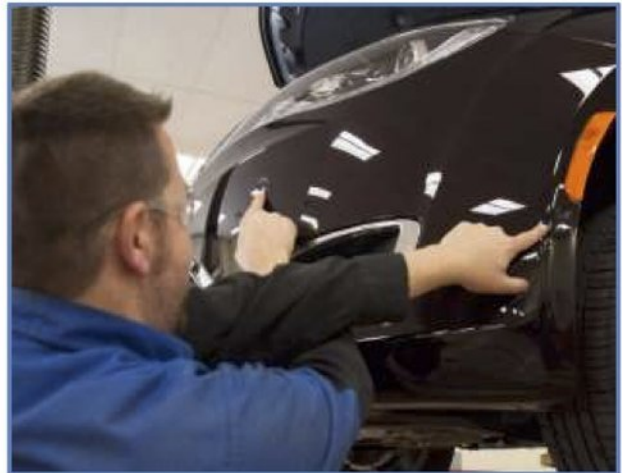
Figure 27: Wrong Sensor Position

An issue that can be easy to miss is a sensor located in the wrong position (Figure 27). Some vehicles use different types of sensors in different locations.

An “incorrect performance” DTC can indicate that the wrong sensor is installed in the wrong location.

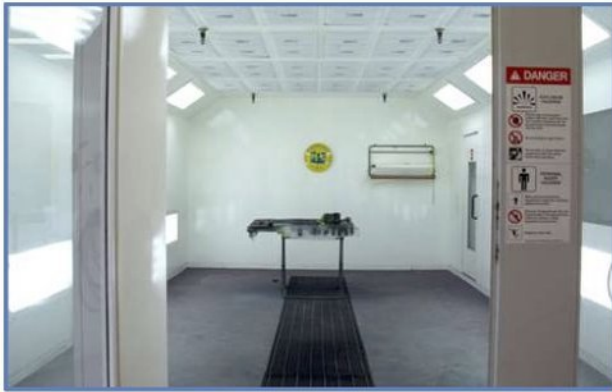
Figure 28: Body Shop

While the body shop (Figure 28) usually takes care of the painting, here are some key things to look out for.

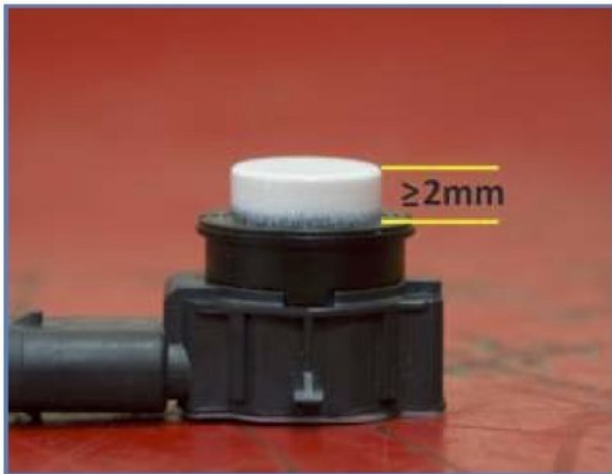
Figure 29: Paint on Sensor Membrane

Confirm that paint extends at least 2 mm down the walls of the membrane (Figure 29).

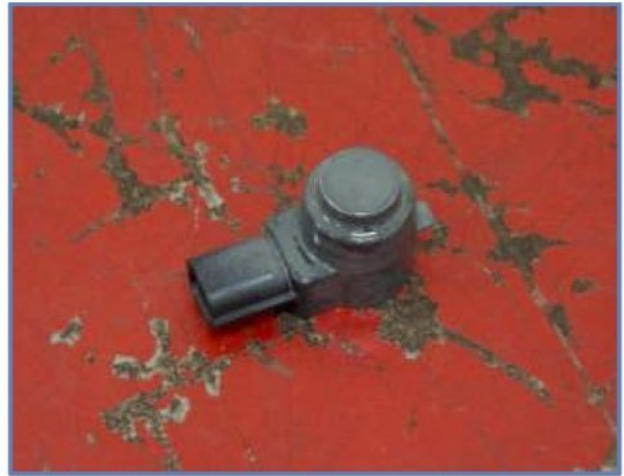
Figure 30: Overspray on Sensor

Verify that the sensor does not have any overspray (Figure 30).

Keep in mind that once a sensor has been painted, it cannot be painted again.

Sensors with paint that is too thick may not perform as expected. This includes attempting to use touch-up paint.
