STAR ONLINE PUBLICATION

Case Number: S1813000001

Symptom/Vehicle Issue: Frame Weld Inspection

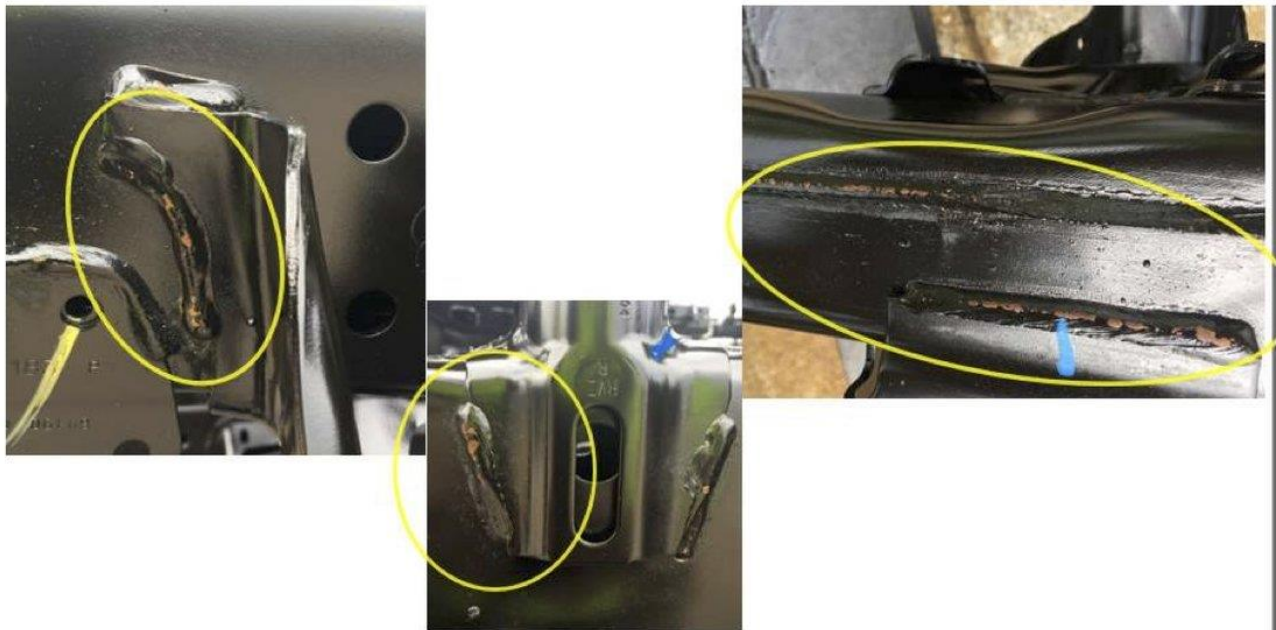
1. Customer complaint of a rusty weld. Fig 1 shows a "silicon inclusion/island" – L the brownish material pictured- which is generally inherent to the MIG welding process of the steel frame with weld wire of this and similar compositions. This occurs when Si deoxidizes (floats to the surface) of the weld pool and is trapped prior to escape by solidification. This is not a weld defect. These deposits are also very slick in nature. Coatings do not stick to the Silicon deposits. No repairs required.

Fig 1 Silicon deposits

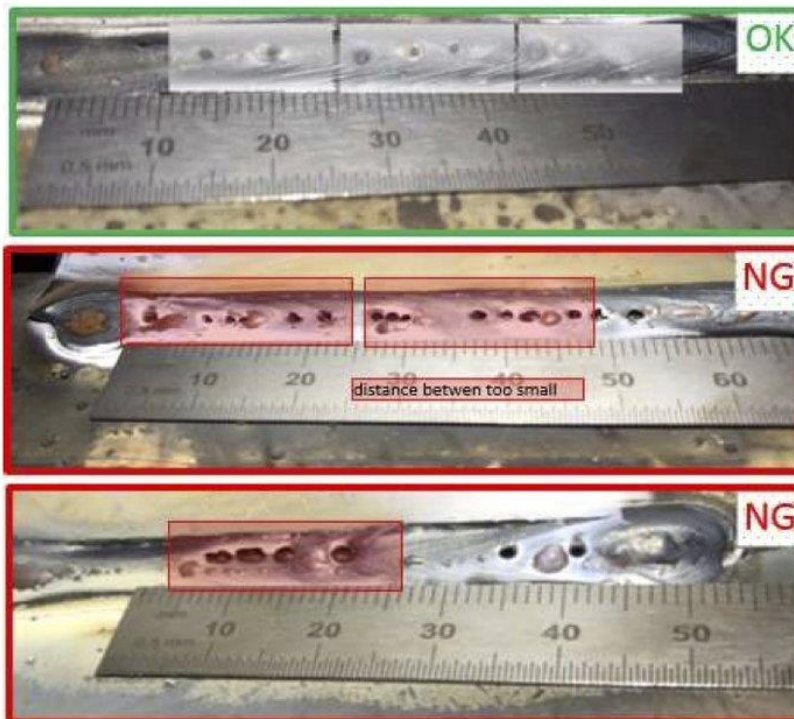
2. Porosity or pinholes in weld beads. FCA welding standard does allow some porosity as it does not affect structural integrity of the joint/welded assembly. Individual pinholes separated by at least their own diameter and other scatter surface porosity is allowable. The total length of porosity (sum of diameters) cannot exceed 6.4 mm in any 25 mm of weld. Fig 2 shows examples of acceptable (OK) and not acceptable (NG) porosity.

Fig 2 Porosity

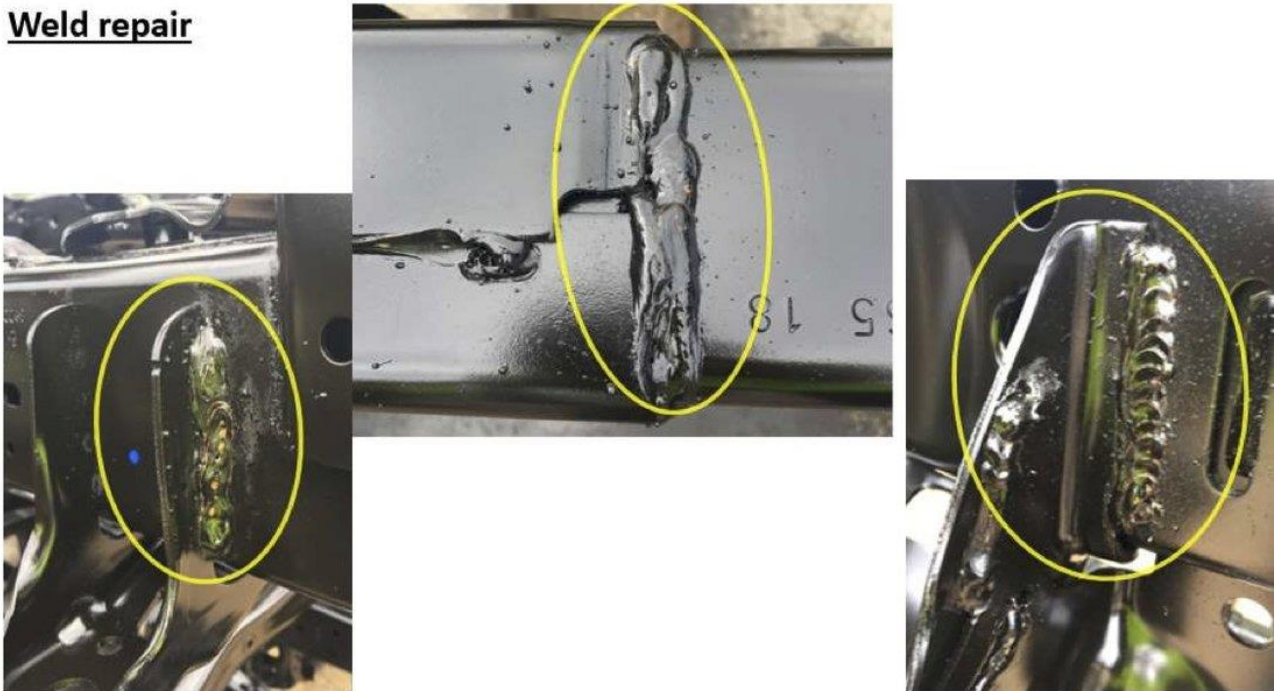
Weld repair

3. Reprocessed weld repair (performed at frame production plant). Applied usually adjacent to an original weld (fig 3) . This is acceptable and inherent to high – volume MIG welding processes. For FCA approved refinishing and corrosion protection following a repair refer to TechCONNECT Collision Tab group 31 - Collision Information/Standard Procedure CORROSION PROTECTION.

Fig 3 Reprocessed weld.

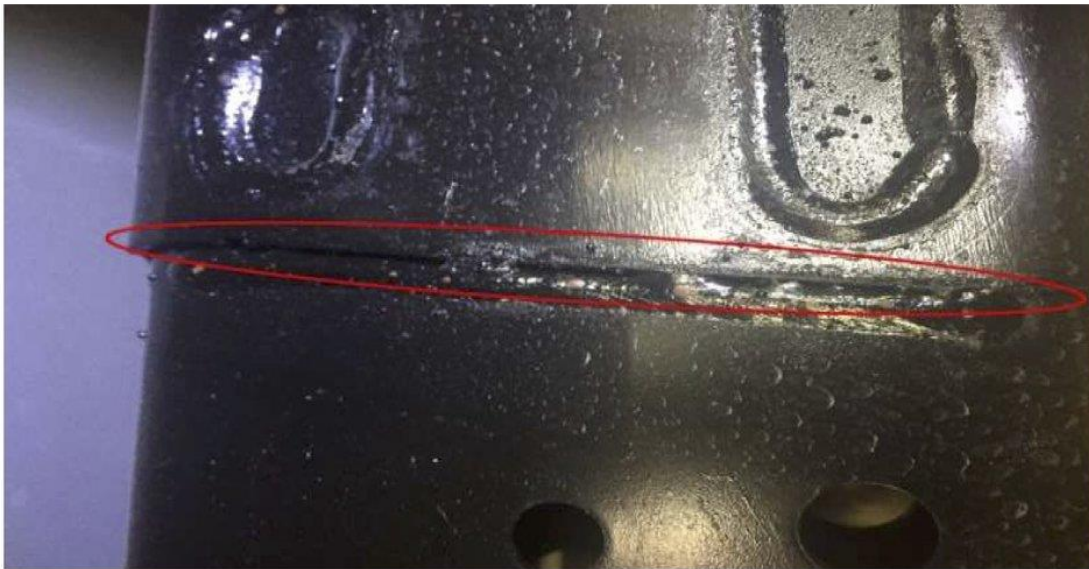
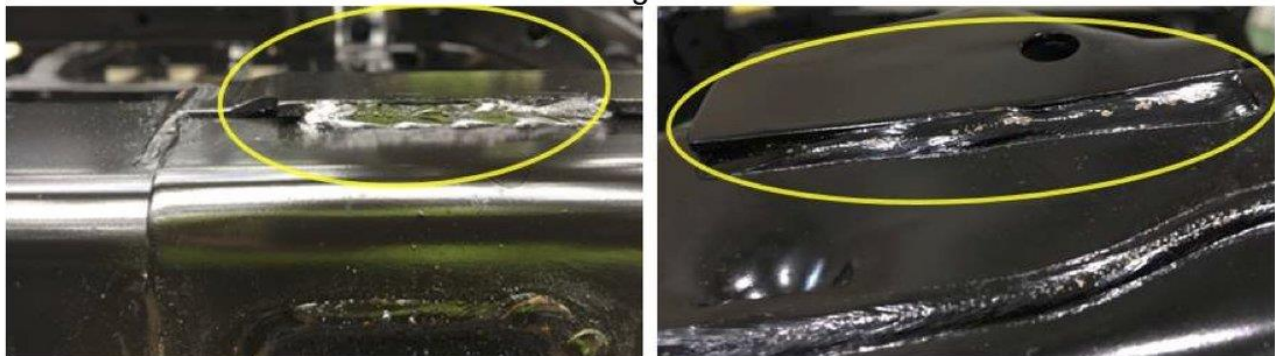
4. Weld joint suspected to be off location or weld joint does not equally overlap both materials. This would require a subject matter expert's diagnostic and potential weld repair. Contact STAR Center with images prior to any repair attempts. See Fig 4 and 5
