<b>REFERENCE:</b>	<b>TSB:</b> 31-001-25 REV. B <b>GROUP:</b> 23 - Body	<b>Date:</b>	August 16, 2025	<b>REVISION:</b>	31-001-25 REV. A
<b>VEHICLES AFFECTED:</b>	2020 - 2025 (JT) Jeep Gladiator 2019 - 2024 (BV) Jeep Renegade 2015 - 2020 (4C) Alfa Romeo 4C 2017 - 2020 (BA) FIAT 124 Spider (Convertible) 2013 - 2019 (FF) FIAT 500 2017 - 2025 (GA) Alfa Romeo Giulia 2018 - 2025 (GU) Alfa Romeo Stelvio 2014 - 2023 (KL) Jeep Cherokee 2013 - 2018 (PF) Dodge Dart 2013 - 2018 (ZD) Dodge Viper 2013 - 2025 (DS) RAM 1500 Pickup 2013 - 2022 (WK) Jeep Grand Cherokee 2013 - 2026 (WD) Dodge Durango 2017 - 2026 (RU) Chrysler Pacifica/Voyager 2015 - 2018 (BU) Jeep Renegade 2018 - 2025 (JL) Jeep Wrangler 2015 - 2023 (LA) Dodge Challenger 2013 - 2014 (LC) Dodge Challenger 2013 - 2023 (LX) Chrysler 300 2017 - 2024 (MP) Jeep Compass 2015 - 2017 (UF) Chrysler 200 2019 - 2026 (D2) RAM 3500 Pickup 2019 - 2026 (DD) 3500 Cab Chassis 2019 - 2023 (DF) RAM 3500 <10K Cab Chassis 2019 - 2026 (DJ) RAM 2500 Pickup 2019 - 2026 (DP) RAM 4500/5500 Cab Chassis			<b>MARKET APPLICABILITY:</b> <input checked="" type="checkbox"/> NA <input checked="" type="checkbox"/> MEA <input checked="" type="checkbox"/> SA <input checked=

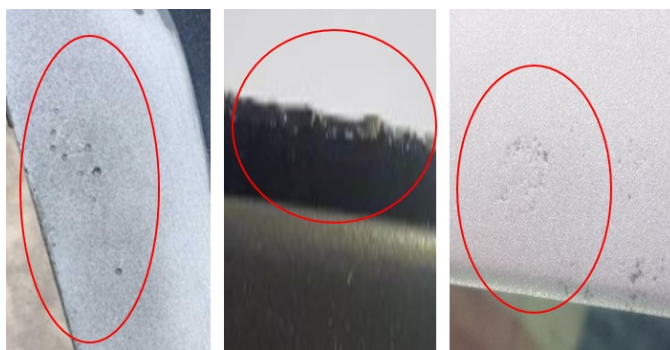
**Fig. 5**

4. After digital imaging or Regional Office approval and removing the initial blistered paint from the panel surface with 80 grit grinding disc, is severe pitting exhibited that cannot be removed with sandpaper, 3M Clean and Strip Disc or equivalent [Fig. 5](#)?
- YES >>> **Replacement of the panel is required.**
  - NO >>> Proceed to [Step 1](#) of the Repair Procedure.

Corrosion Examples After Paint Has Been Removed

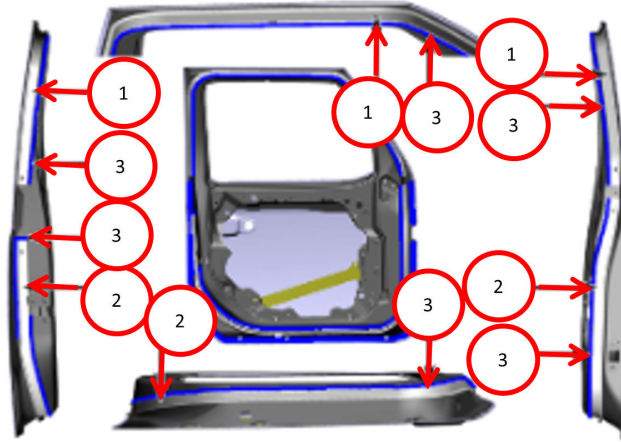
**Fig. 6**  
Seam Sealer Locations

Replacement door assemblies do not include seam sealers Fig. 6. Seam sealer must be applied to all seams as identified in Service Library.

- 1 - Upper Weatherstrip Channel
- 2 - Lower Weatherstrip Channel
- 3 - Seam Sealer

Seam Sealer Locations and Approved Seam Sealers are identified in Service Library in the Collision Information section under the Locations and Approved Materials tabs.
