NUMBER: 08-001-19

Flash Over The Air (FOTA) Software Update UAQ Radio

2018 (JL) Jeep Wrangler

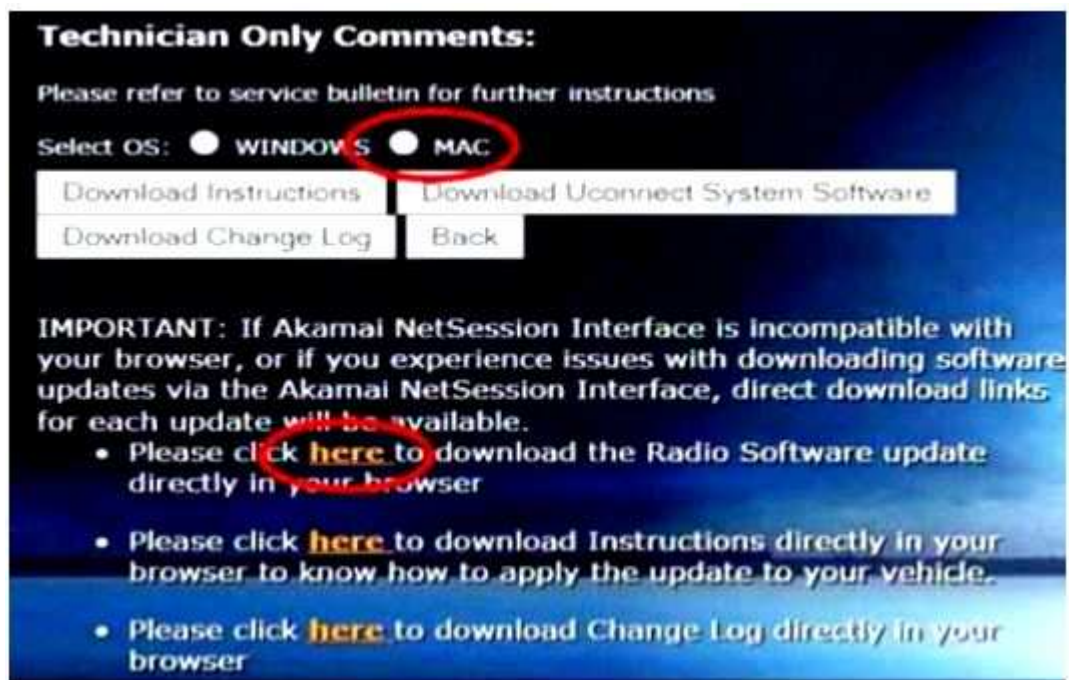
Fig. 3

MAC Download Steps

5. Download the software update file to your local PC's desktop. Make sure to select the "MAC" radial button for all downloads (Fig. 3) .

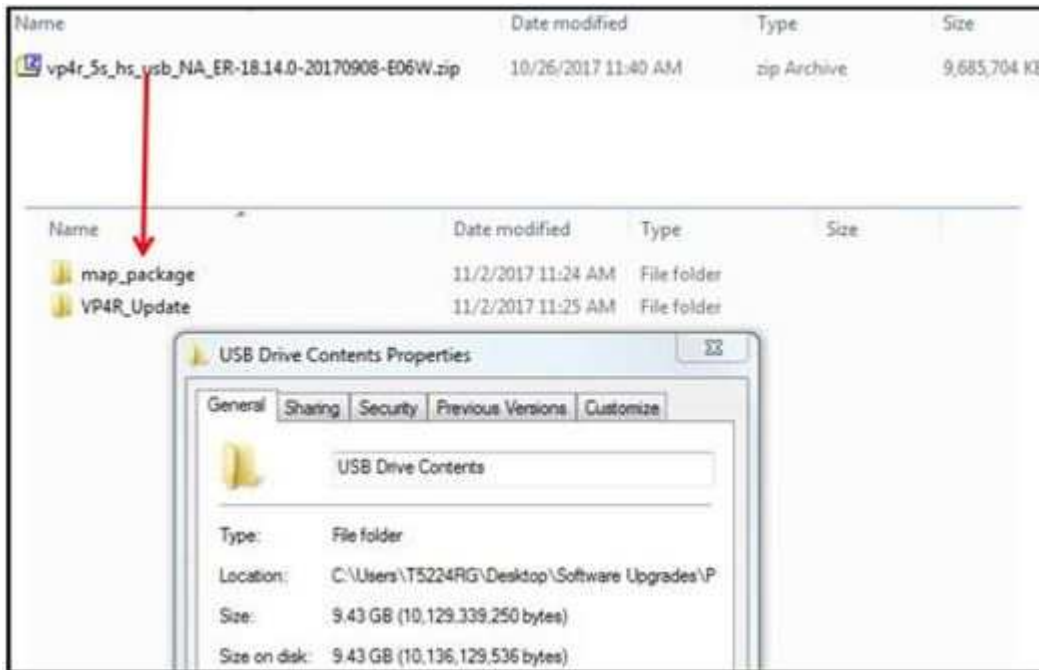
Fig. 4
Files/Folders In The USB Flash Drive

- Unzip all the files to the root folder of USB flash drive. Files should not be within a zip folder. Your USB files should look like (Fig. 4) when you open it, displaying multiple files/folders.

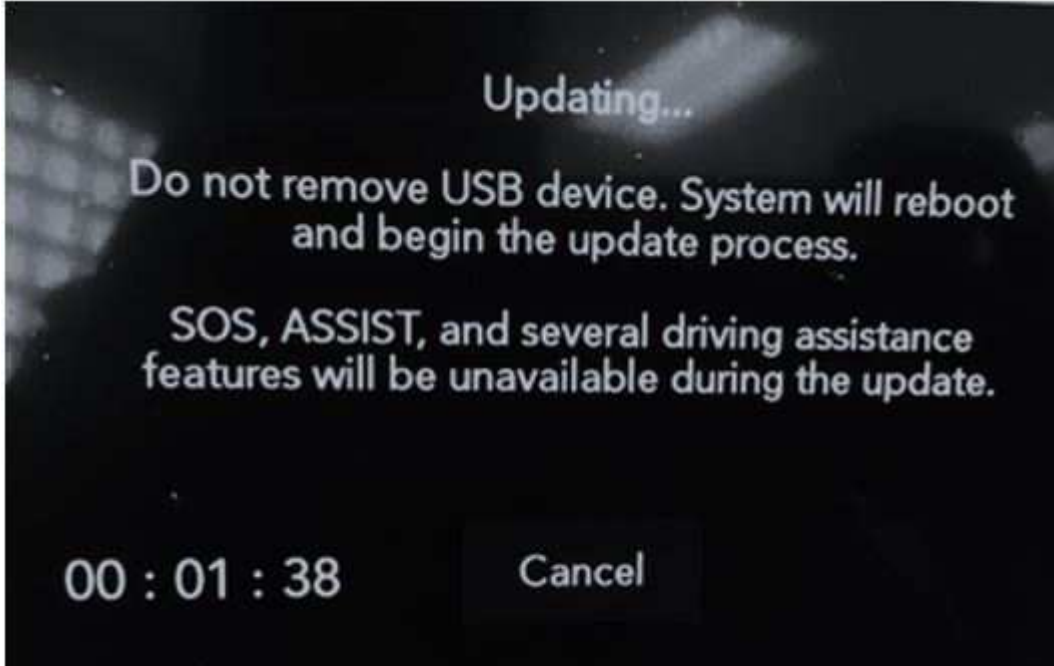
Fig. 8
Radio Update Process Begins

13. When the radio starts updating, the screen in (Fig. 8) will be displayed.
