WARRANTY BULLETIN

NO: D-23-04

SUBJECT: 2018 - 2023 (Current) Jeep
Wrangler (JL) and 2020 - 2023 (Current)
Jeep Gladiator (JT) - Corrosion Warranty
Claim Simplification (Rev. A)

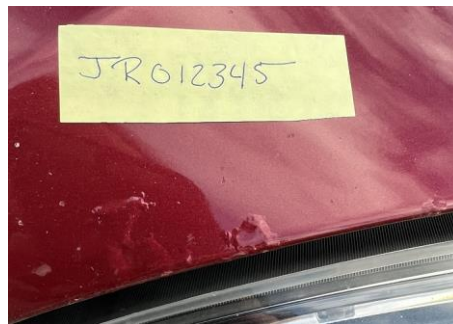
VIN Example (Fig. 3)

Dealers will need to take photos of the affected areas identified during the inspection to support the repair. A clear photo of the corrosion is needed and **MUST** include the VIN. The VIN can be included on a sticky note, written with a grease pen, a copy of the RO in the photo, masking tape, etc. (Figure 3)
