## MODULE-INVERTER 110VAC

**Full Repair Kit: 68137873AA**

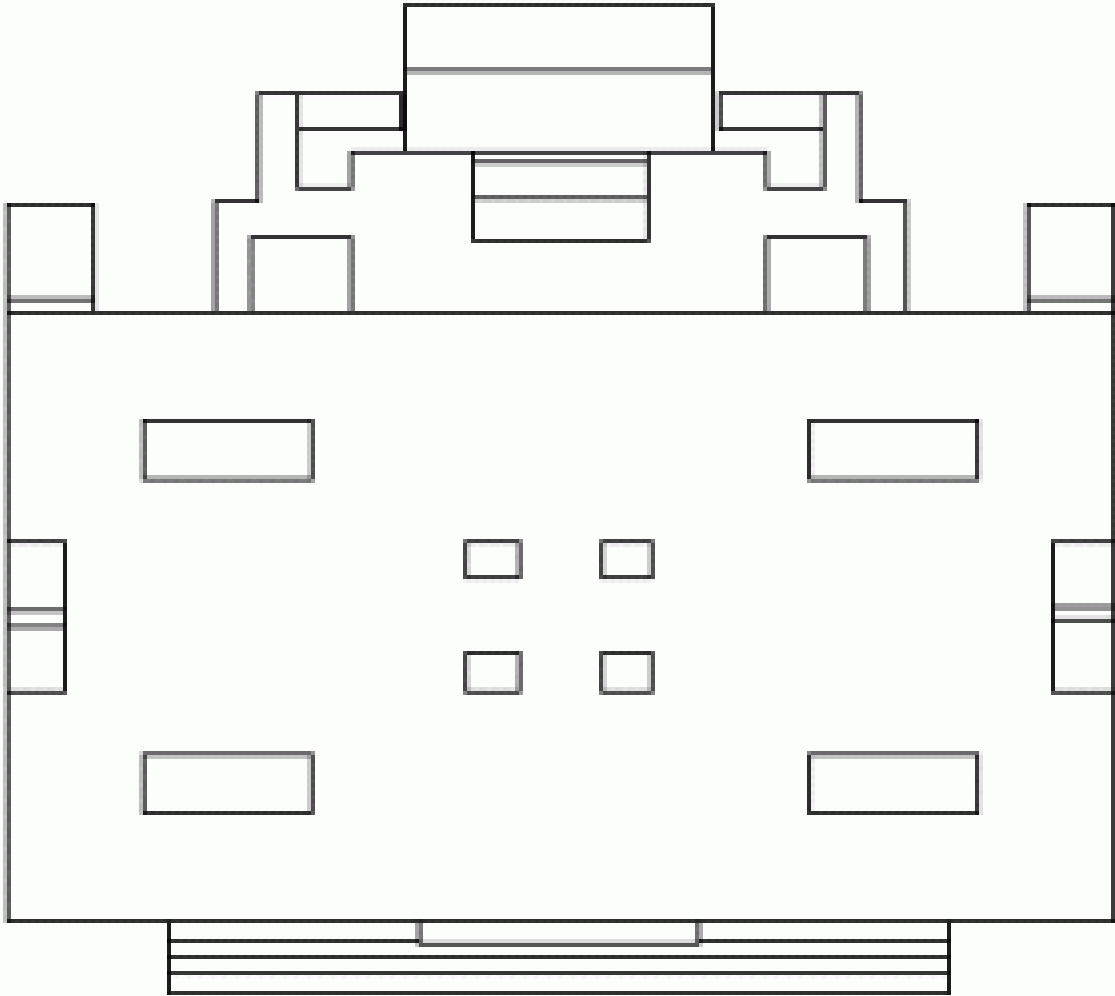
**End View**

4  
8

5

Cav	Circuit	Gauge	Color	Function
1	P802	1.0	GN	VOLT AC LINE 2
2	N0	0	NA	NO CONNECT
3	N0	0	NA	NO CONNECT
4	A401	2.0	RD	FUSED B(+)
5	P801	1.0	GN	VOLT AC LINE 1
6	P805	0.35	GN	VOLT AC LINE 3
7	N0	0	NA	NO CONNECT
8	Z910	2.0	BK	GROUND
