## MODULE-INVERTER 220VAC

Full Repair Kit: 68496346AA

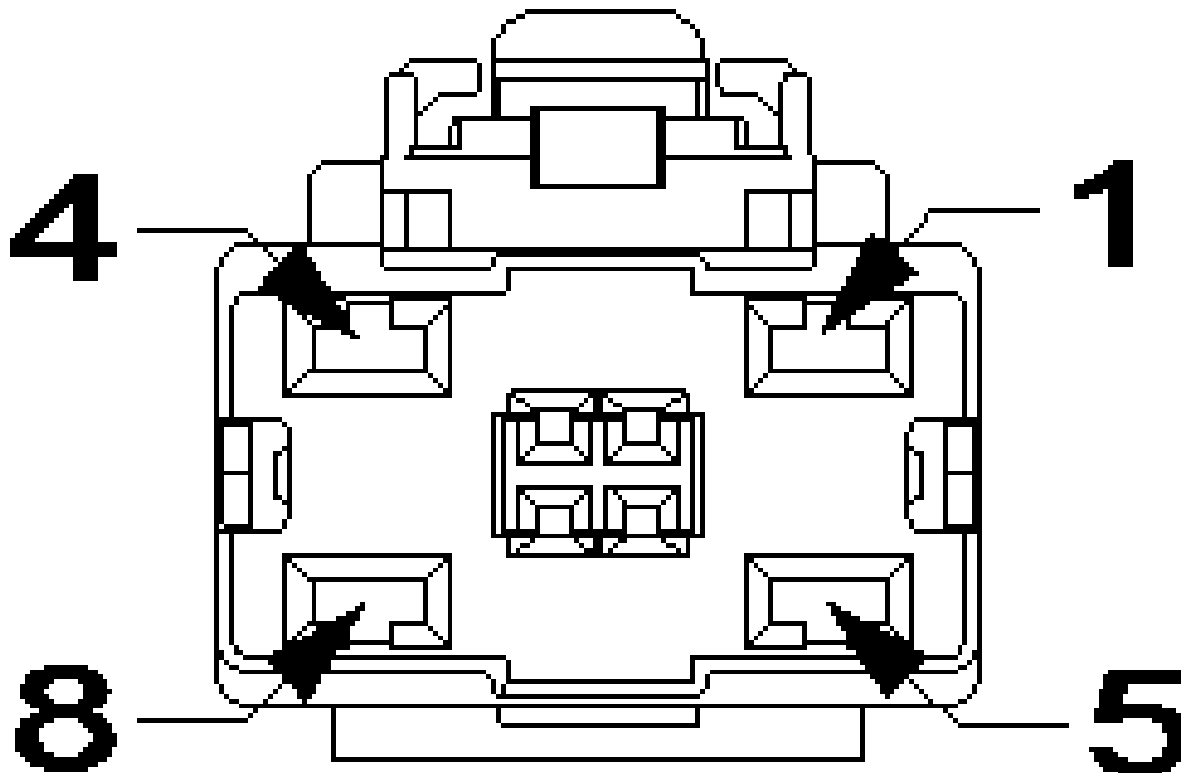
End View

Cav	Circuit	Gauge	Color	Function
1	P802	1.0	GN	VOLT AC LINE 2	
2	N0	0	NA	NO CONNECT	
3	N0	0	NA	NO CONNECT	
4	A401	2.0	RD	FUSED B(+)	
5	P801	1.0	GN	VOLT AC LINE 1	
6	P805	0.35	GN	VOLT AC LINE 3	
7	N0	0	NA	NO CONNECT	
8	Z910	2.0	BK	GROUND
